# Your Inspection Report

107 - 5th Avenue  
Montreal, QC

RE: Report No. 1358, v.2  
107 - 5th Avenue  
Montreal, QC

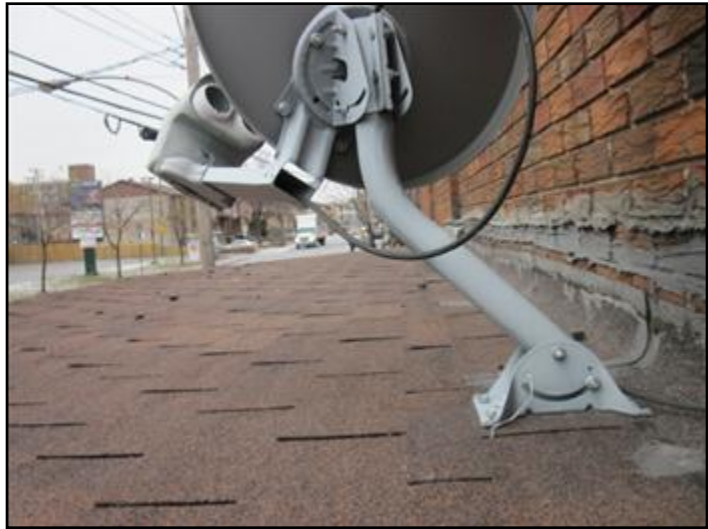
We noted a shingle roof covering on the roof over the convenience store entrance.

Shingles are not recommended for use on low slope roofs.

*Shingles installed on low slope roof*

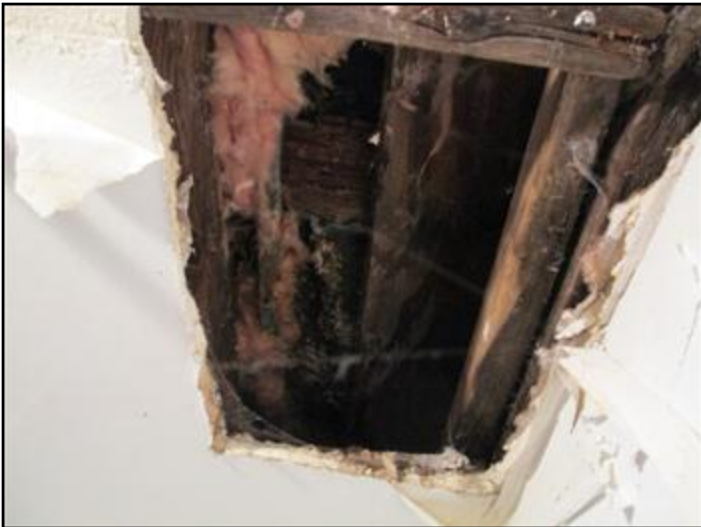
We noted traces of water infiltration in the rear storage area of the convenience store.

*Roof support weakened by prior water infiltra*

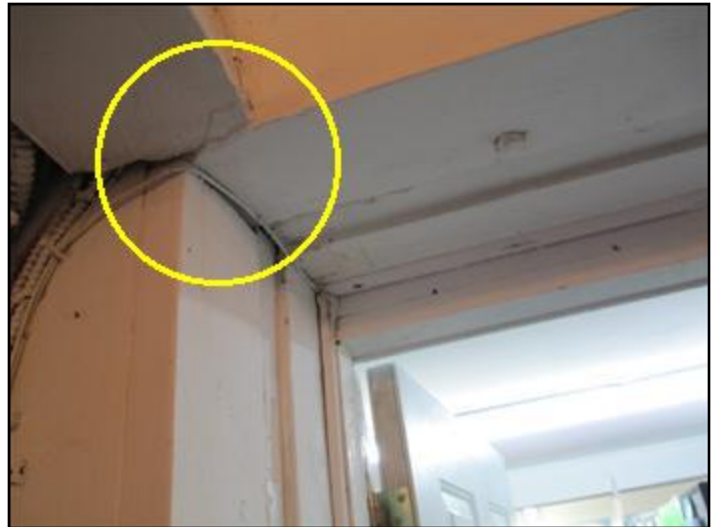
We also saw water stains in the ceiling where the storage room meets with the main building structure.

We find the design of this addition is likely to increase water infiltration problems.

*Water stains at rear junction storage room*

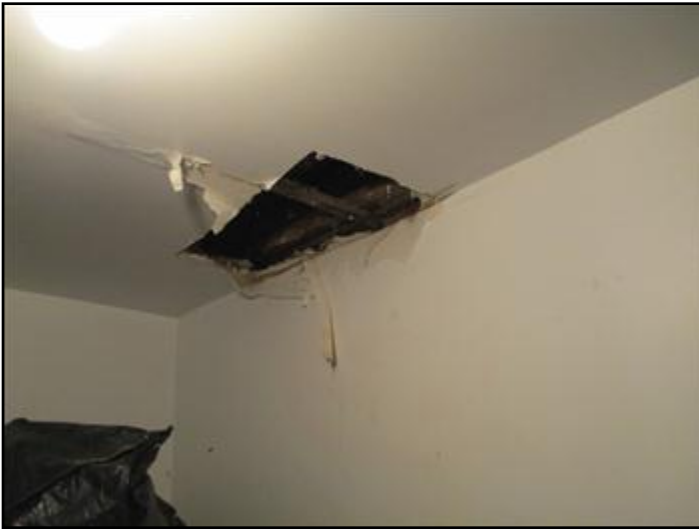
Water infiltration in right rear storage

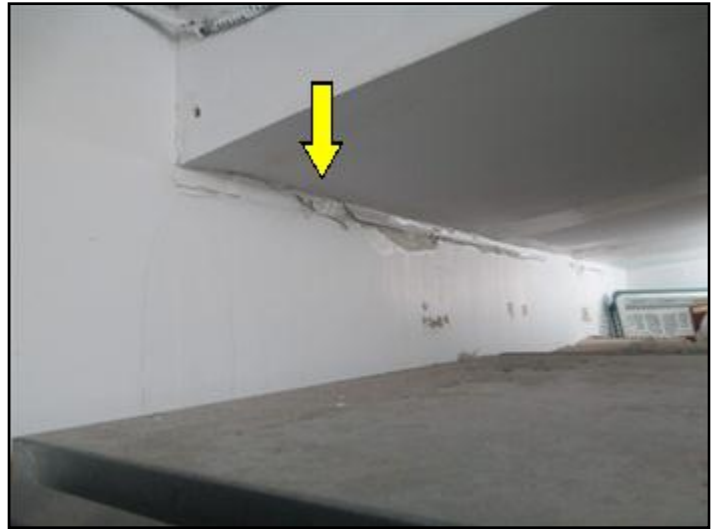
Water damage at rear junction storage room

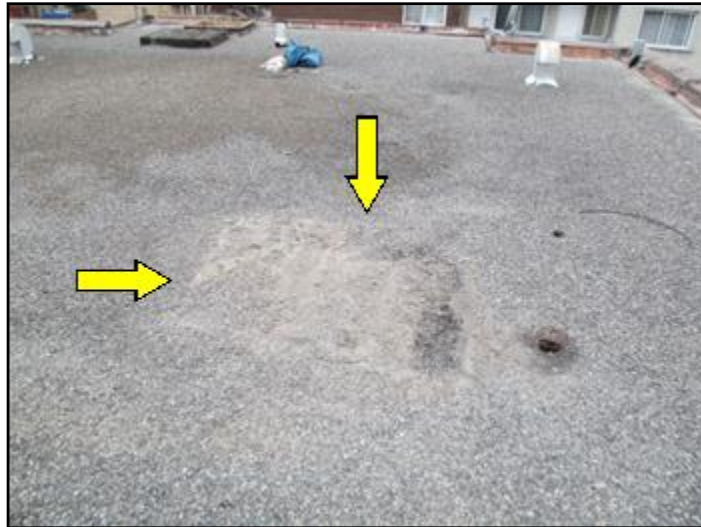
We noted a patch has been made on the membrane indicating there has been some previous leakage problems.

Roof patch visible near drain

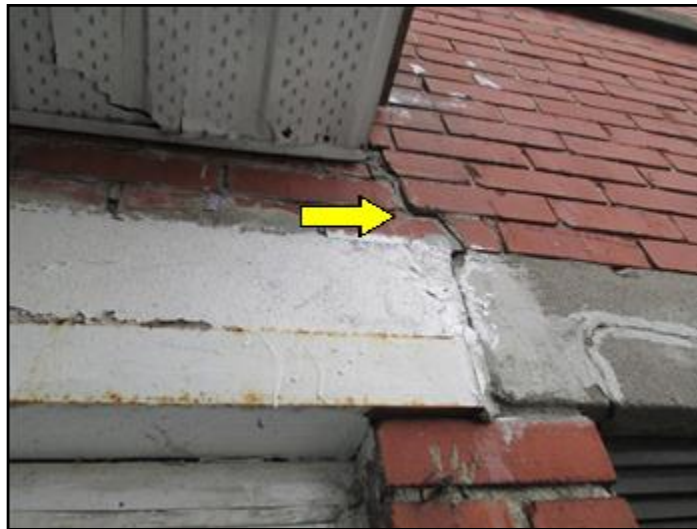
We noted a crack in the brick masonry wall at the rear.

*Crack in rear masonry wall*

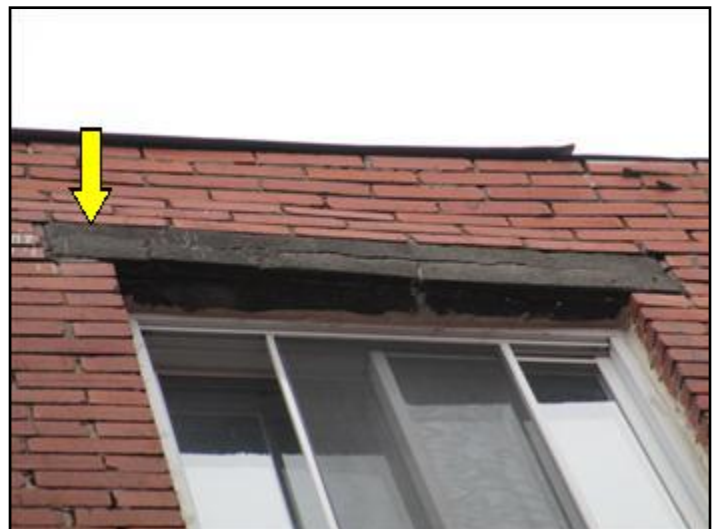
*The lintel is pulling away from the building*

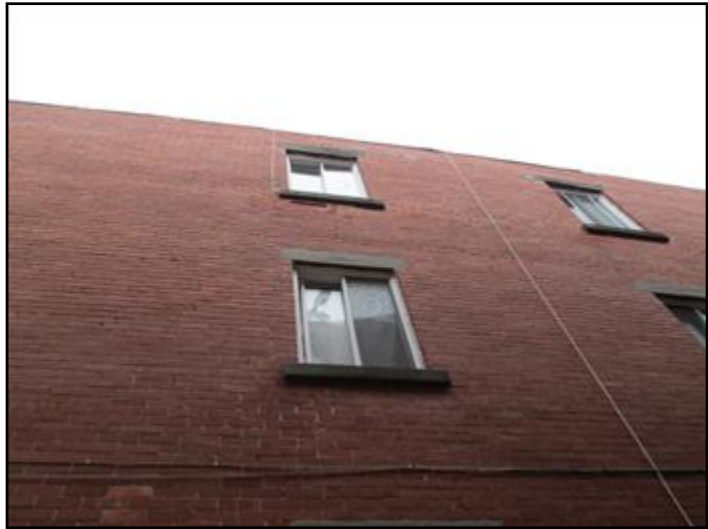
We noted the brick masonry on the right wall has begun to wave and to pull away near the top of the wall.

This poses a safety risk and should not be left unattended, temporary anchors may be required until proper repairs are completed.

*Bowing and waves of third floor masonry*

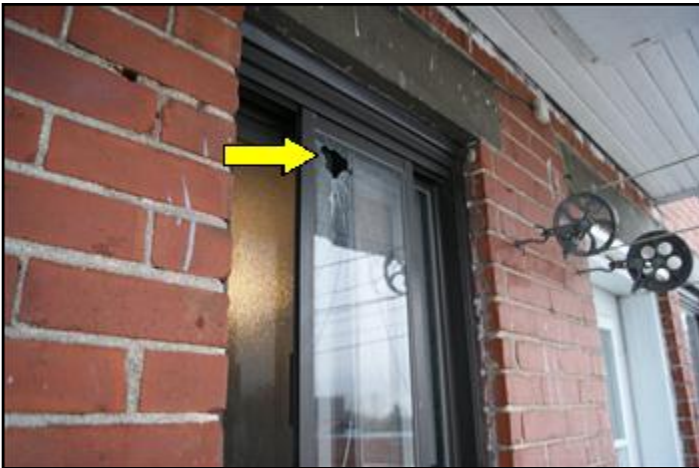
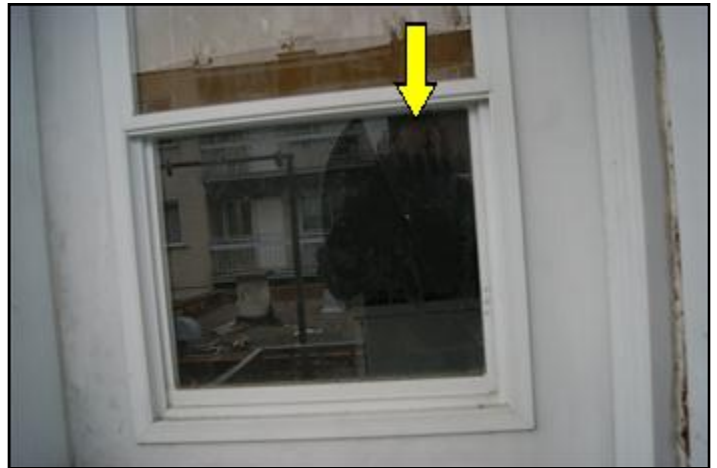
We noted some broken glass panes on a door and a window at the rear of the building. These should be repaired before the winter and as soon as possible as they represent a safety risk.

*Broken glass pane at rear*

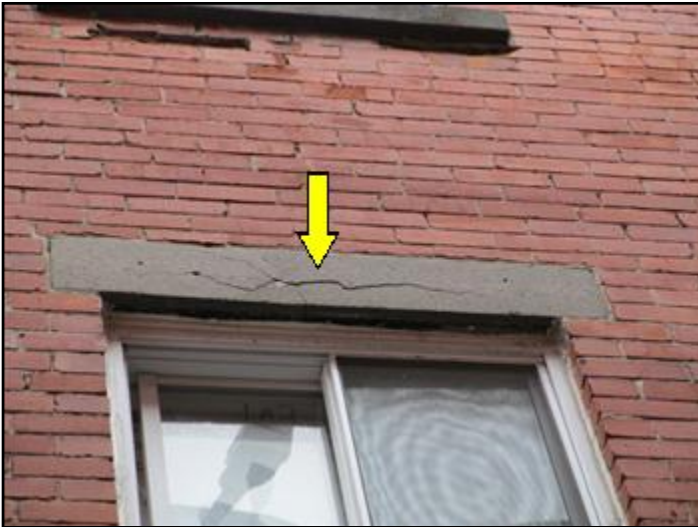
We noted extensive damage to several of the concrete window sills and lintels. Also most of the front pre-cast decorative masonry elements are cracked and/or pulling away from the structure. These should be replaced at the same time as the masonry work is done on the right wall.

*Cracked window lintel right wall*

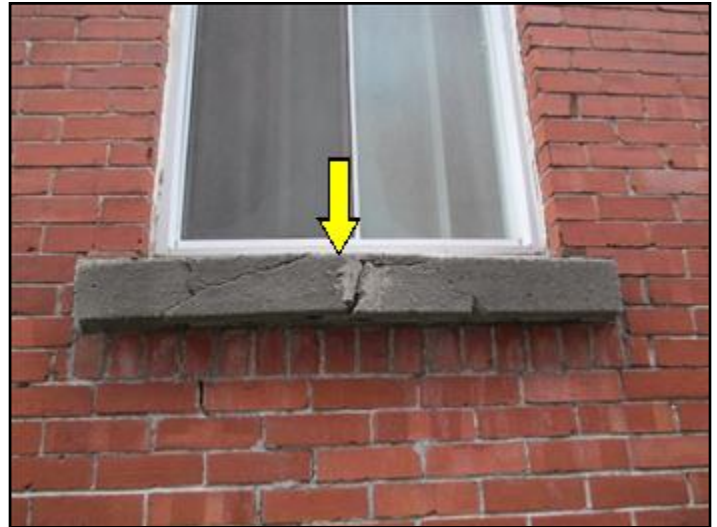
*Deteriorated window sill right wall*

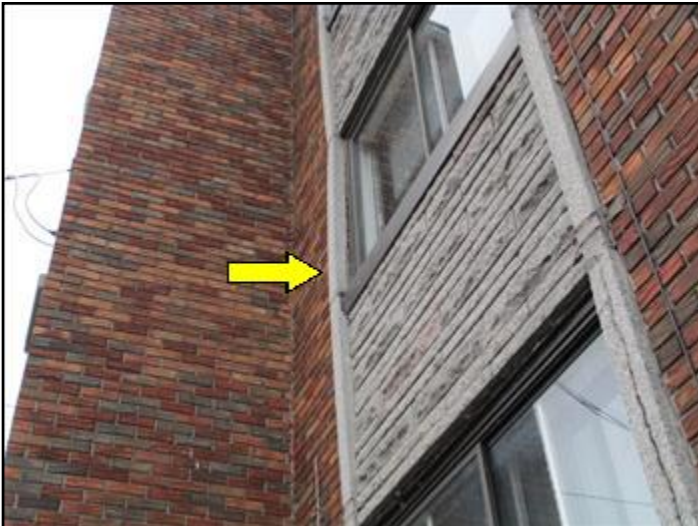
*Pre-cast masonry pulling away*

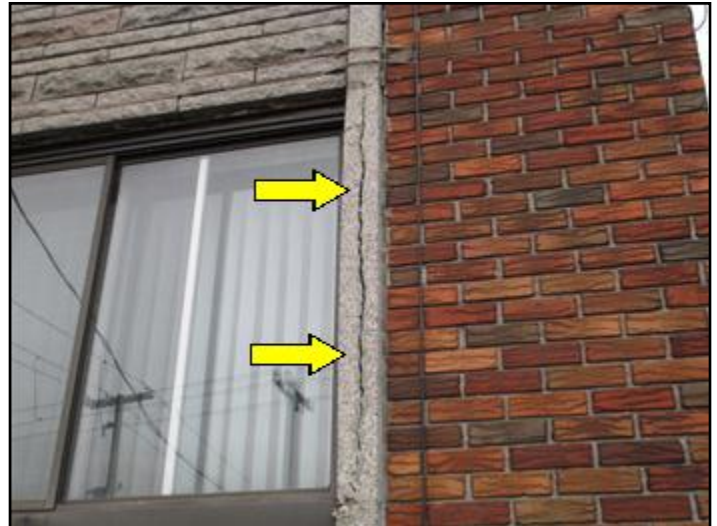
*Pre-cast masonry cracked*

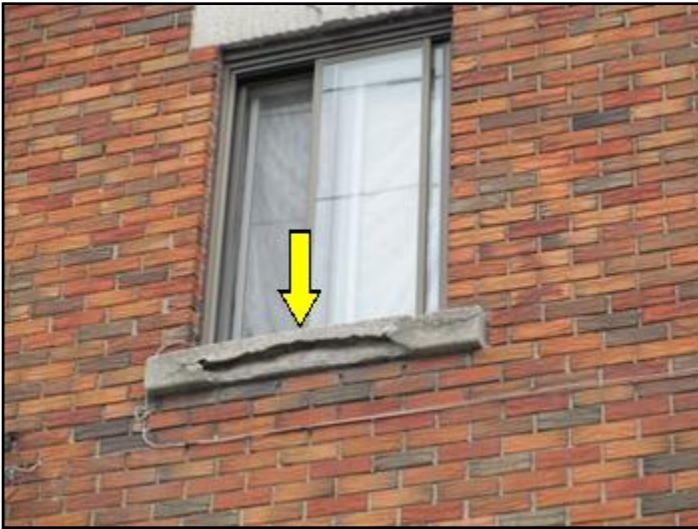
Deteriorated window sill left wall

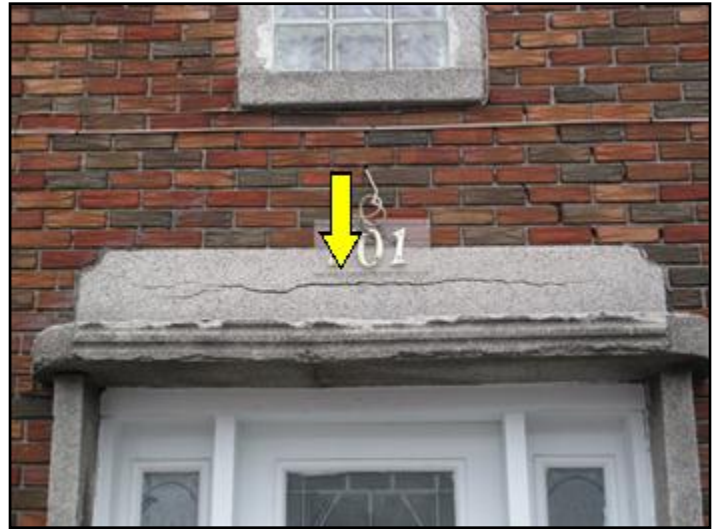
Pre-cast masonry cracked

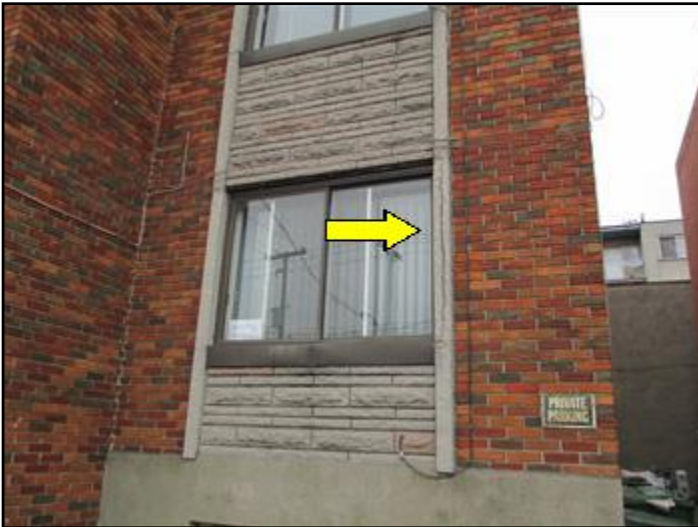
Pre-cast masonry cracked

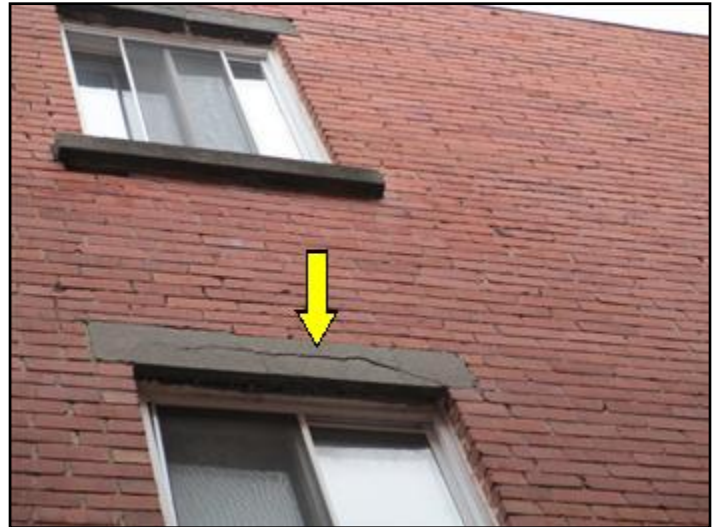
Cracked window lintel right wall

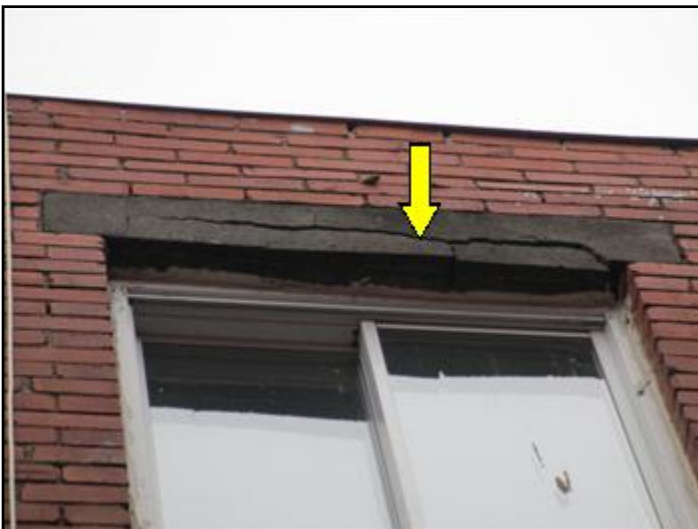
Cracked window lintel right wall

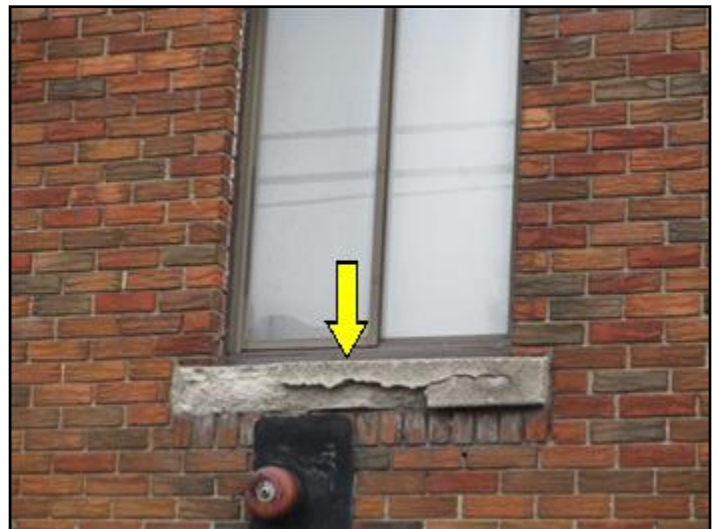
Deteriorated window sill left wall

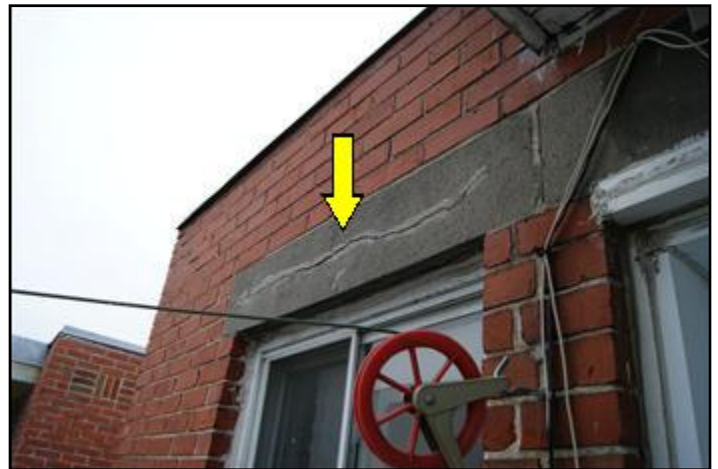
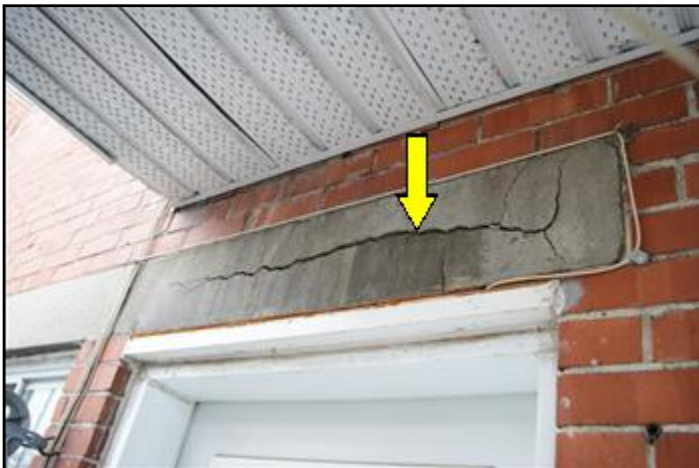
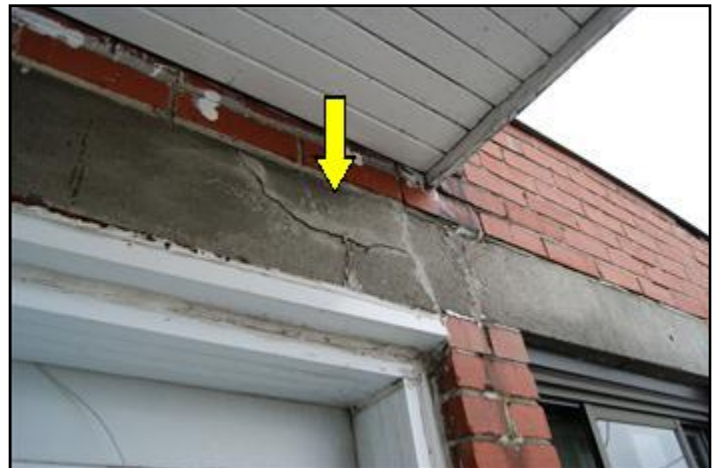
*Cracked window lintel rear wall*

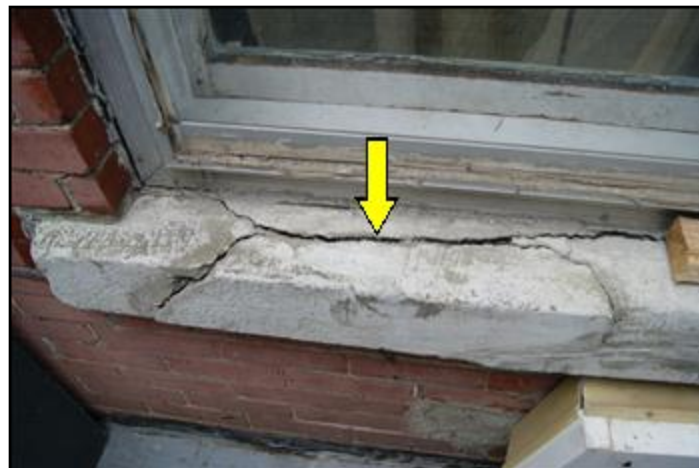
*Cracked window sill rear wall*

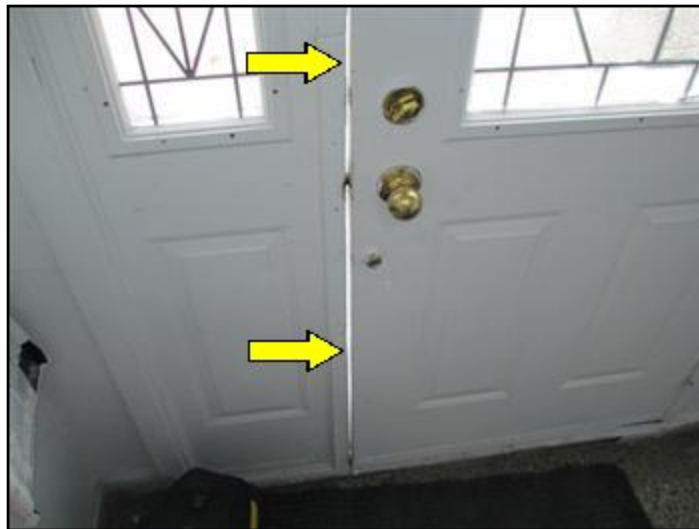
We noted the front main entrance door does not seal properly allowing significant air leakage.

*Significant air leakage around front door*

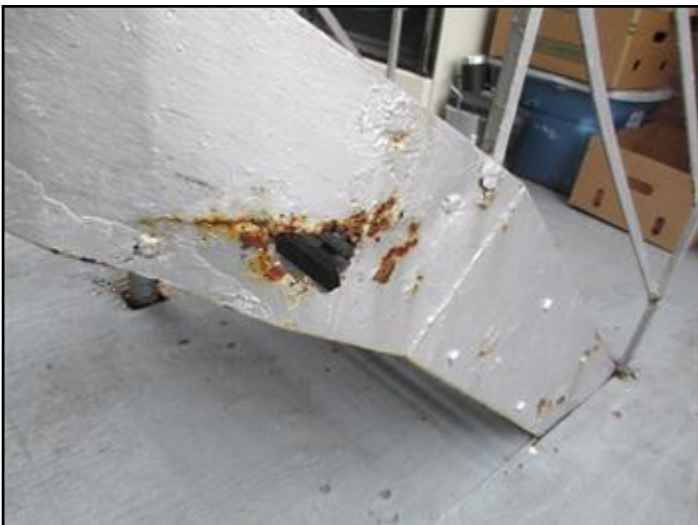
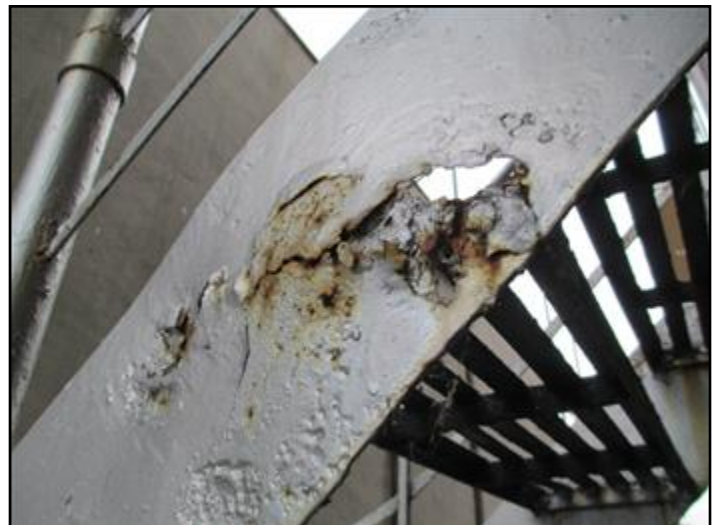
We noted the rear exterior fire escape stairs are severely corroded.

The structural integrity of these stairs is compromised and they require replacement.

*Rear fire escape stairs are severely corroded*

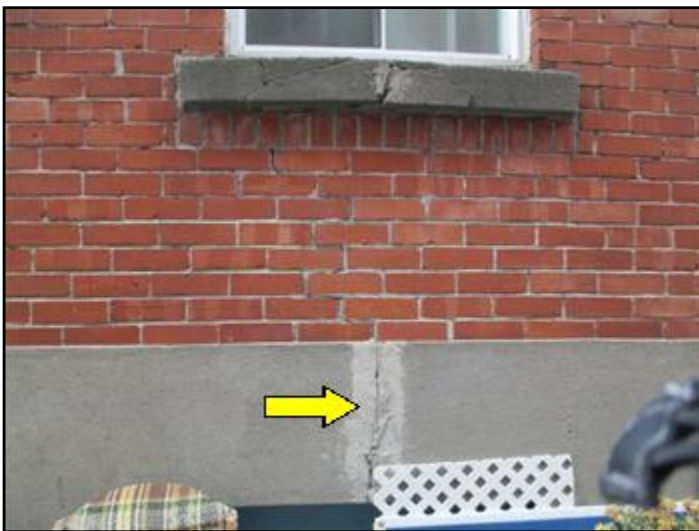
We noted two cracks that do not pose any significant risk to the structure of the building but which should be professionally repaired.

Foundation crack in right wall

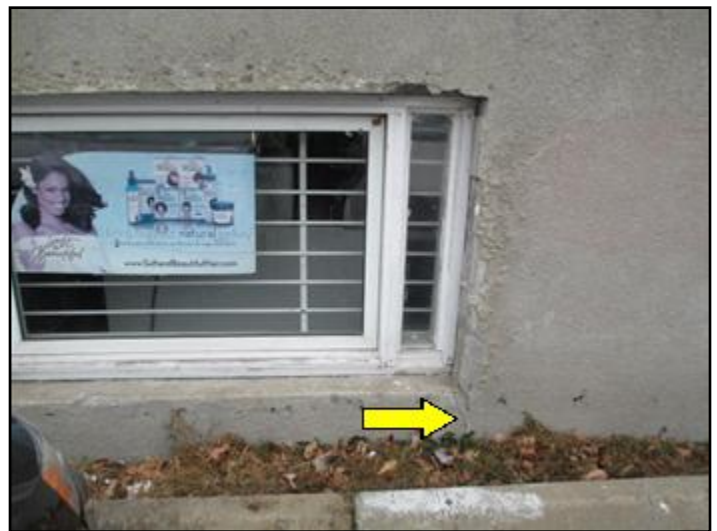
Foundation crack in left wall

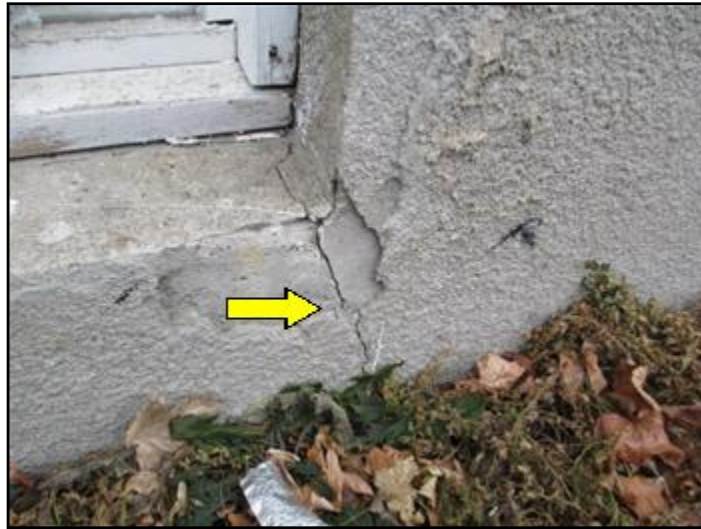
*Foundation crack in left wall*

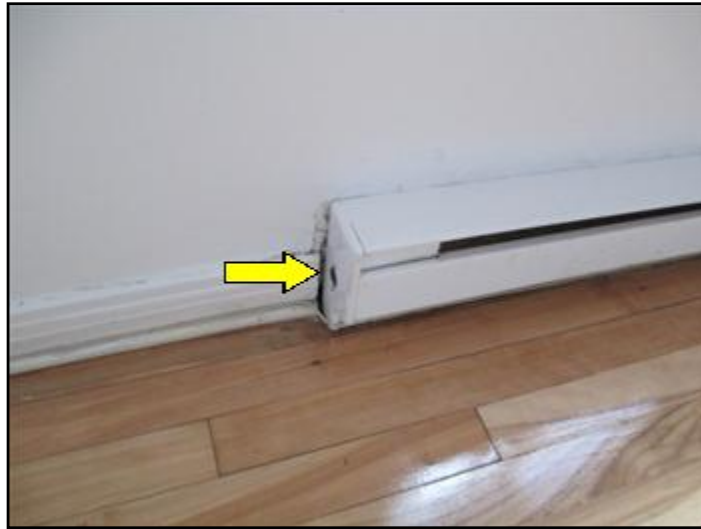
Control knob missing in bedroom of apt 7

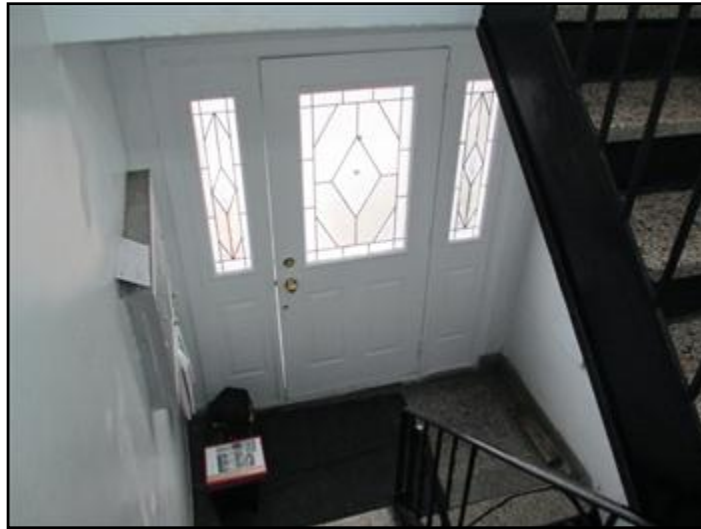
*Missing heater in front staircase*

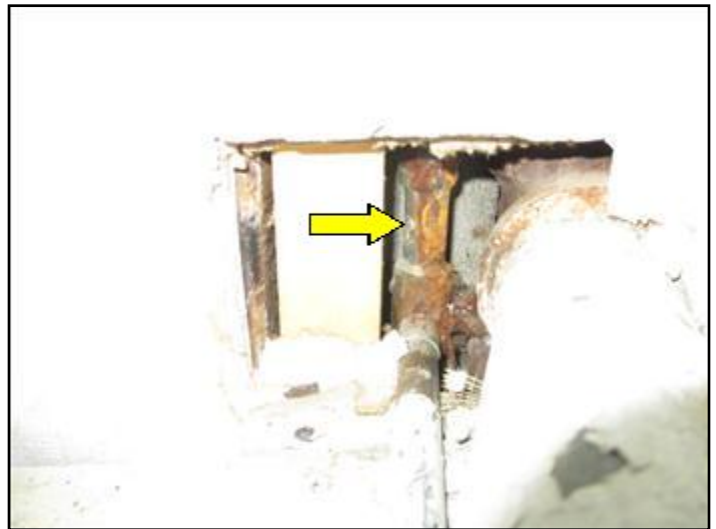
Water flow appears somewhat restricted in certain apartments and we found some traces of corrosion on exposed pipes.

Corrosion of galvanized steel pipe

Although we cannot accurately predict when replacement will become necessary we recommend budgeting for replacement within the next three years.

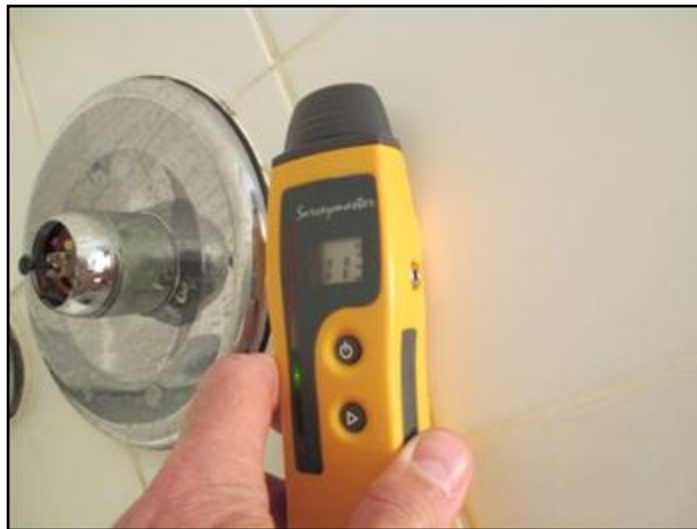
The bath and shower faucet is damaged and needs to be replaced.

*Bath/shower faucet in apt 3*

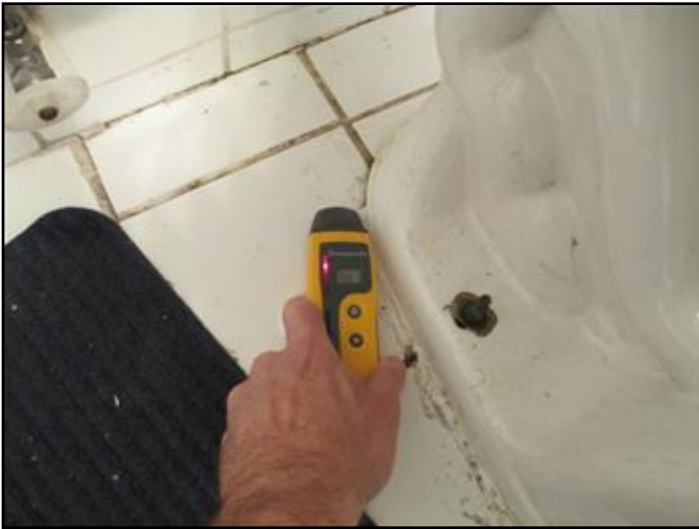
A test was performed around the toilets of each unit using a GE Surveymaster protimeter, the results indicate the presence of high moisture levels under the ceramic flooring in apartments 5 and 7.

High moisture detected under ceramic of apt 5

Recommend removing the toilet to examine the condition of the floor and replacing the gasket.

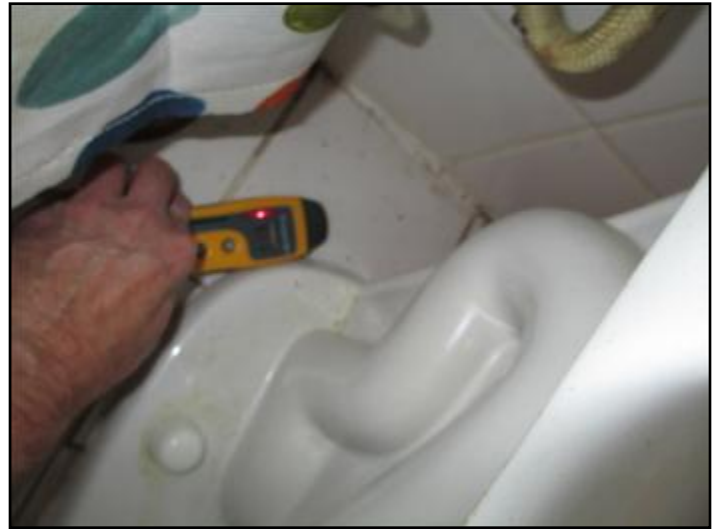
High moisture detected under ceramic of apt 2

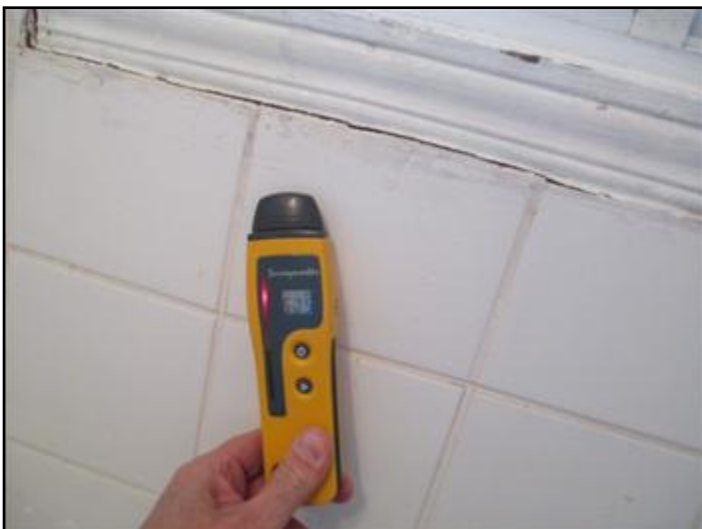
We found evidence of water infiltration in apartments # 4 and 6 behind the ceramic wall covering.

It appears water has been infiltrating around the window frame and may have caused damage to the wall structure.

*High moisture level detected in apt #6*

The ceramic should be removed to determine the extent of the damage and effect the necessary repairs.

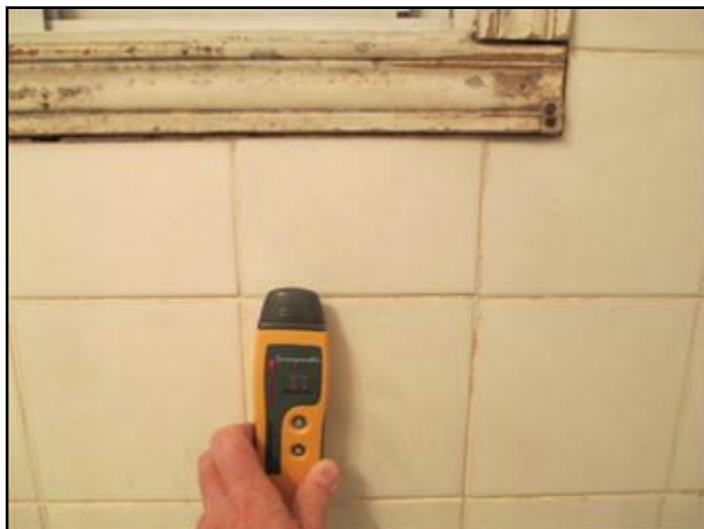
*High moisture level detected in apt #4*

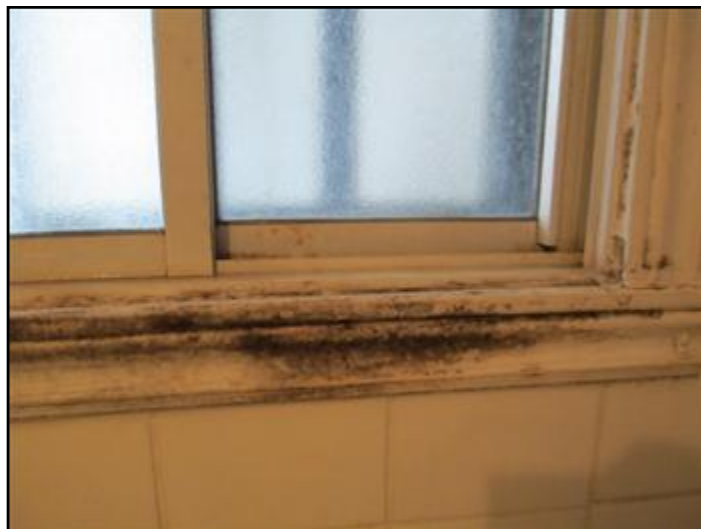
*Appearance of mold in bathroom of apt 2*

Recommend all window treatments be replaced with water/mold impervious materials.

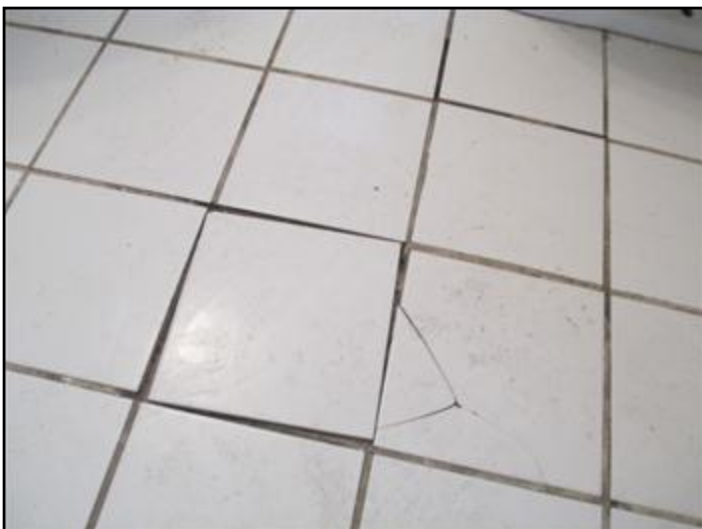
We found a lot of the ceramic floor covering cracked and in some cases loose.

Cracked ceramic tiles in apt 6

We recommend removing all cracked ceramic as this poses a safety risk and replacing the floor covering in the affected areas.

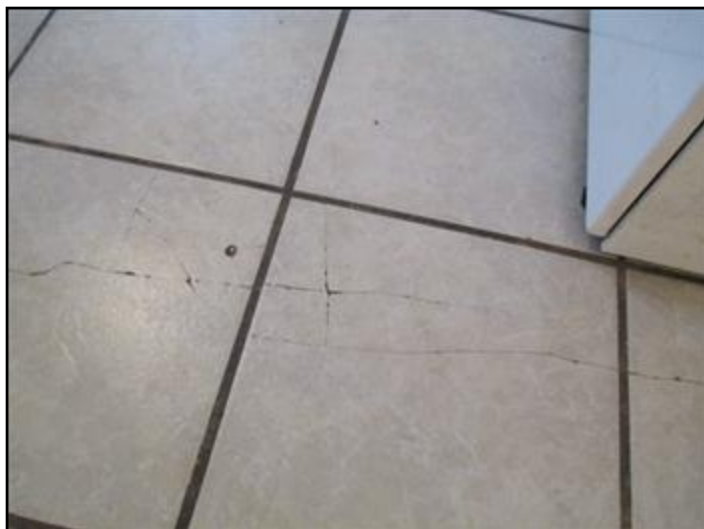
Cracked ceramic tiles in apt 5

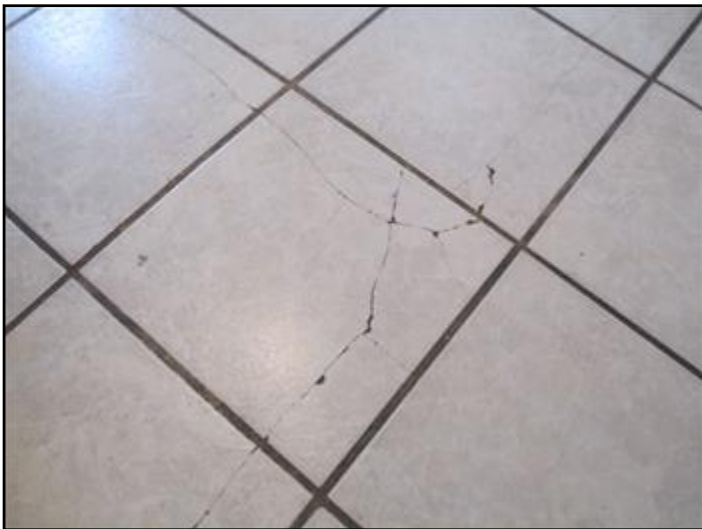
Cracked ceramic tiles in apt 5

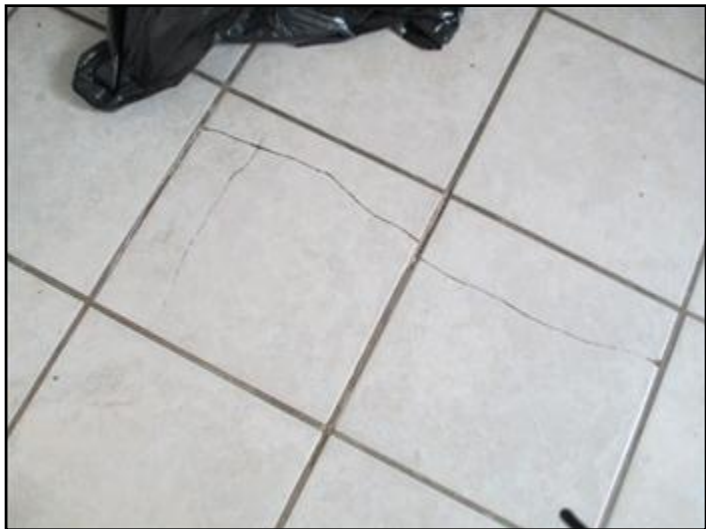
Cracked ceramic tiles in apt 4

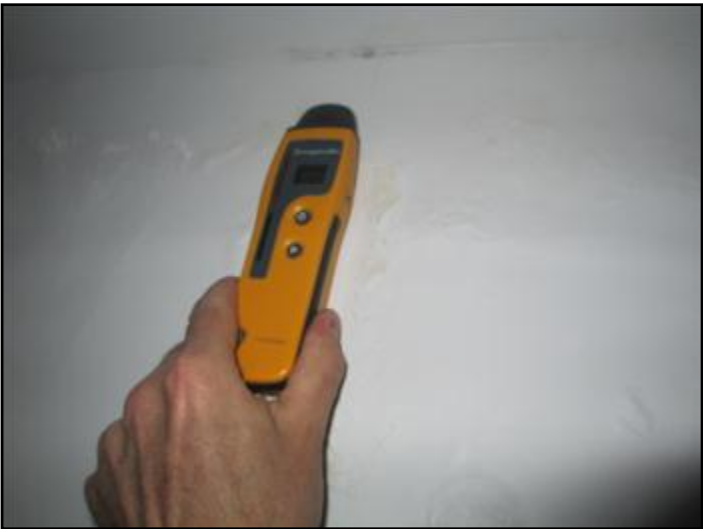
Evidence of prior water infiltration was found one of the bedrooms of apartment 6. Apparently a roof leak had occurred and was repaired. A test of the area was performed using a GE Surveymaster protimeter and the results indicated normal moisture levels. Refer to comments concerning the roof membrane in the roof section.

Test of water damaged area shows normal moist

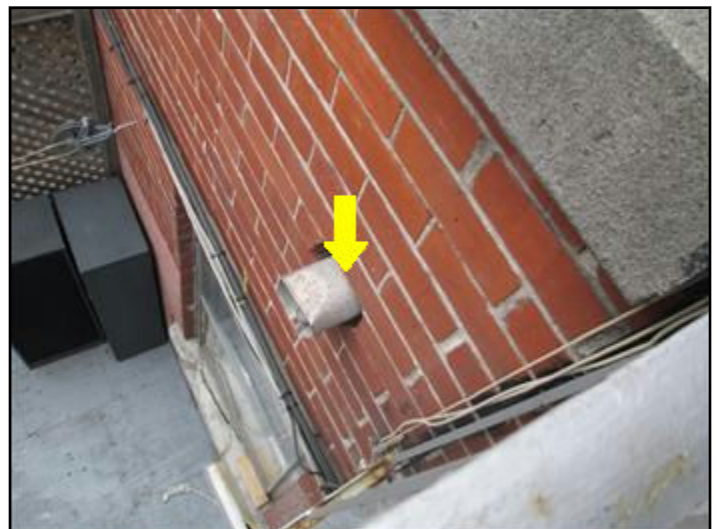
This can allow water and cold air to infiltrate inside the wall cavity and should be corrected immediately.

Weather hood missing or loose
