Your Inspection Report

3142 Cannondale Ave
Montreal, QC

INSPECTION DATE:
Thursday, December 13, 2012

RE: Report No. 1360
3142 Cannondale Ave
Montreal, QC

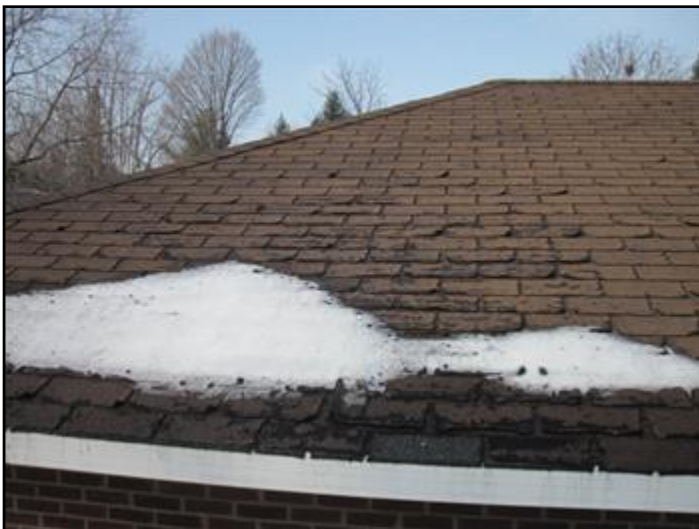
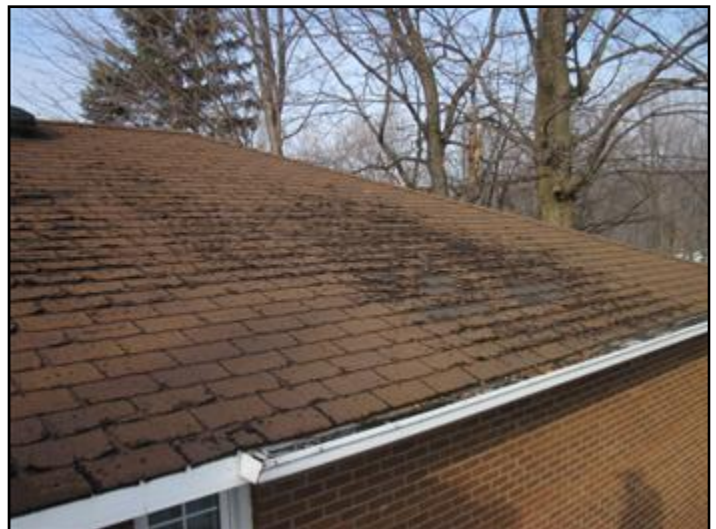
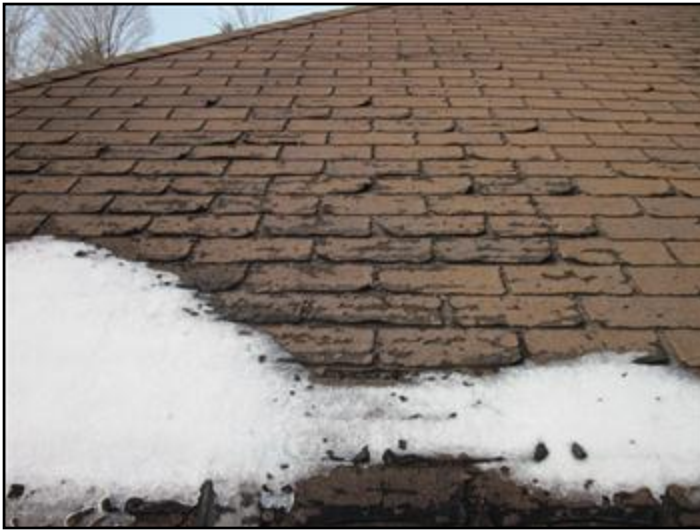
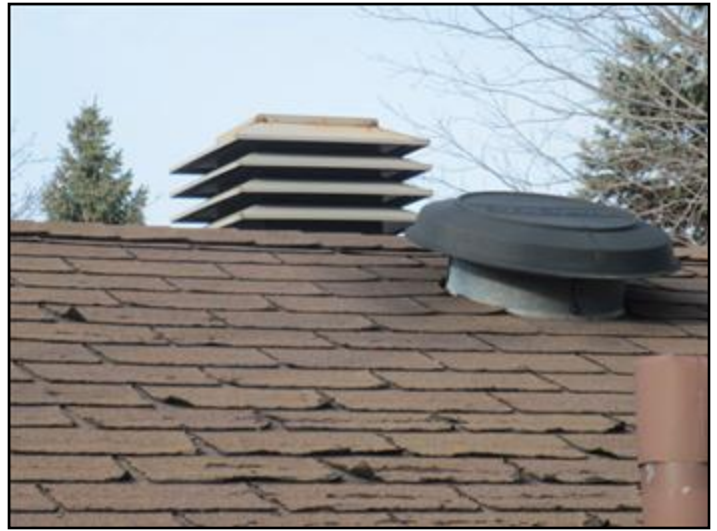
Our examination of the roof confirmed that the shingles have reached the end of their normal life span. Although we did not detect any immediate water infiltration we recommend the covering be replaced without delay as soon as the weather permits.

Roof shingles in poor condition

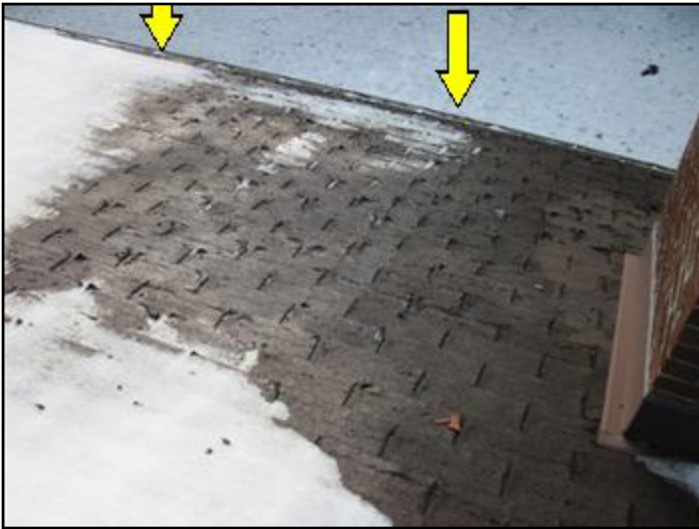
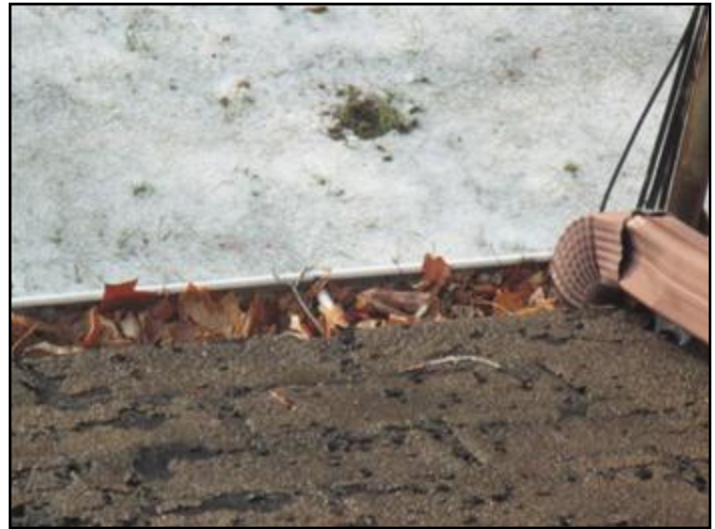
We noted the rear roof gutter was leaking, during our visit on the roof we noted it is clogged and needs to be cleaned.

Rear gutter clogged and leaking

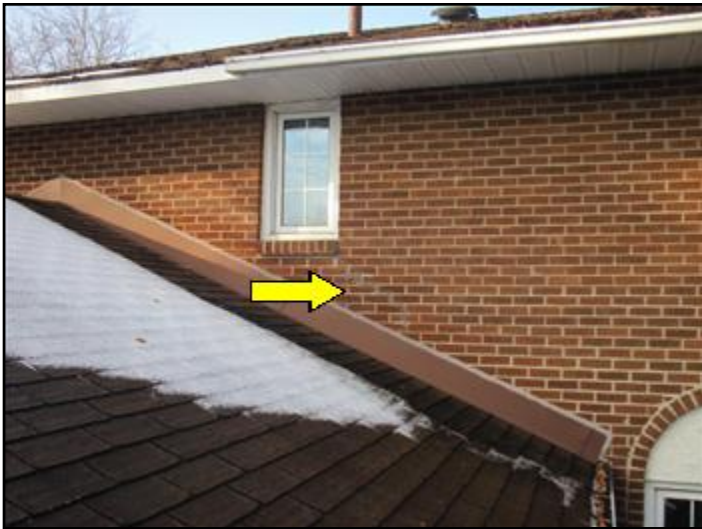
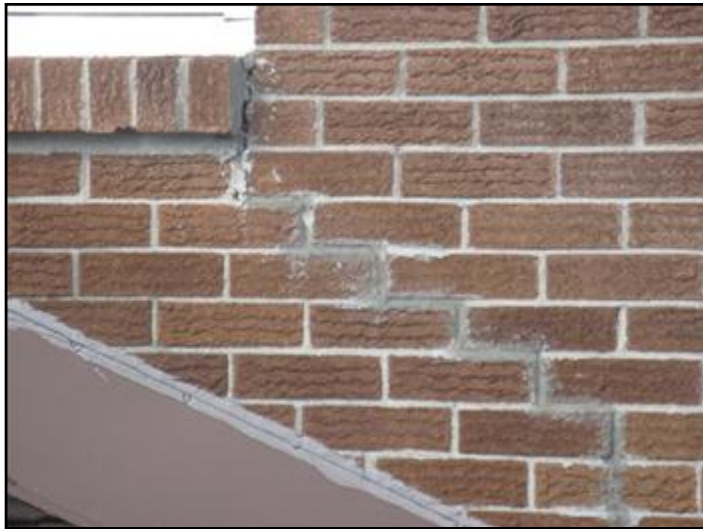
We noted some cracks in the brick masonry that appears to be the result of some differential movement in the structure. Recommend repairs be done by a qualified mason.

Crack in left brick wall second floor

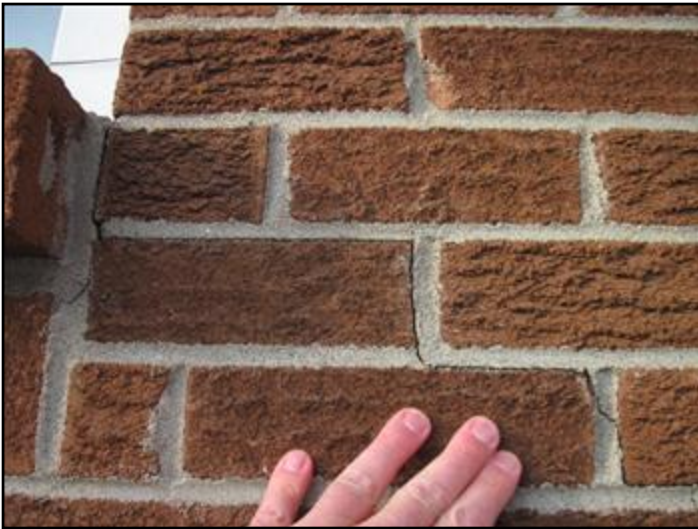
Crack in left brick wall middle section

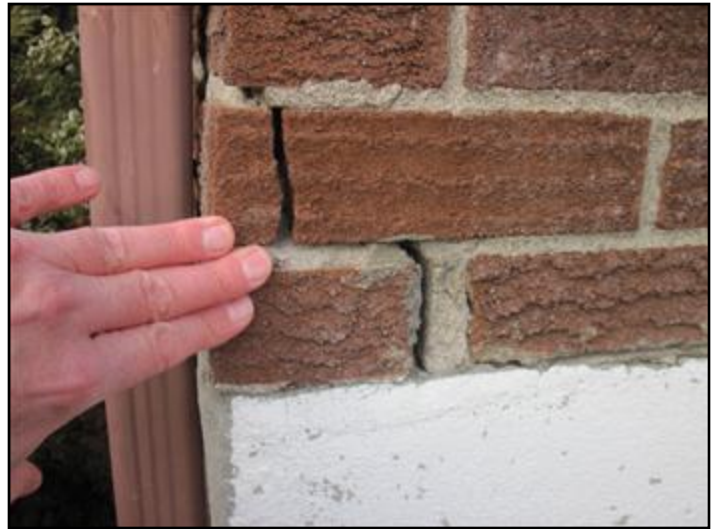
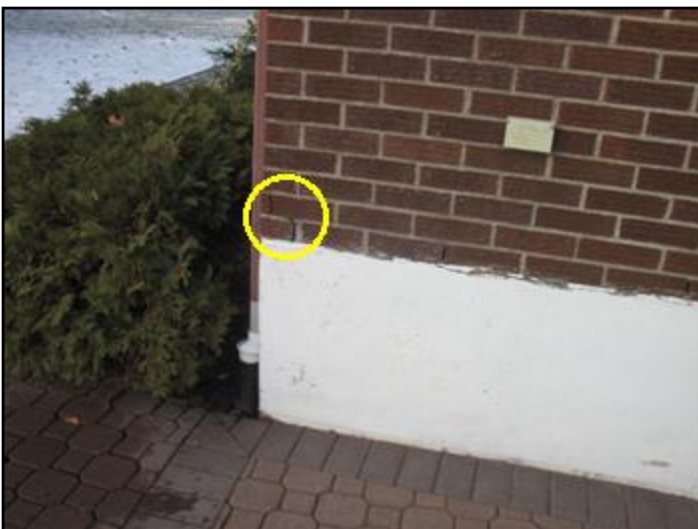
Crack in left brick wall rear corner

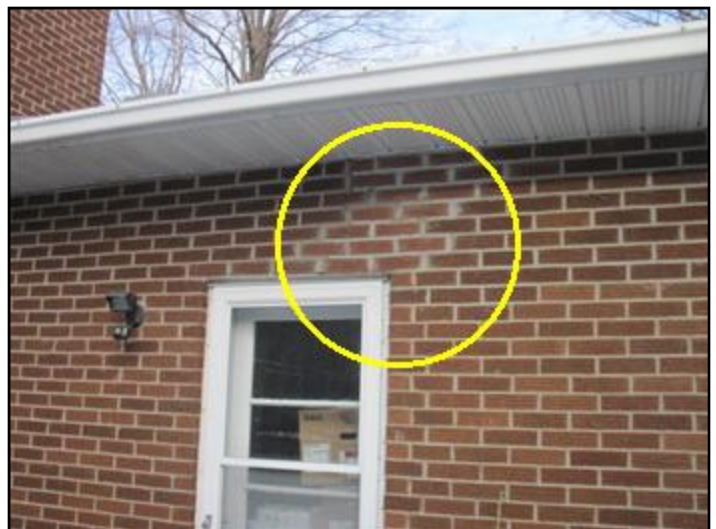
Crack in rear brick wall

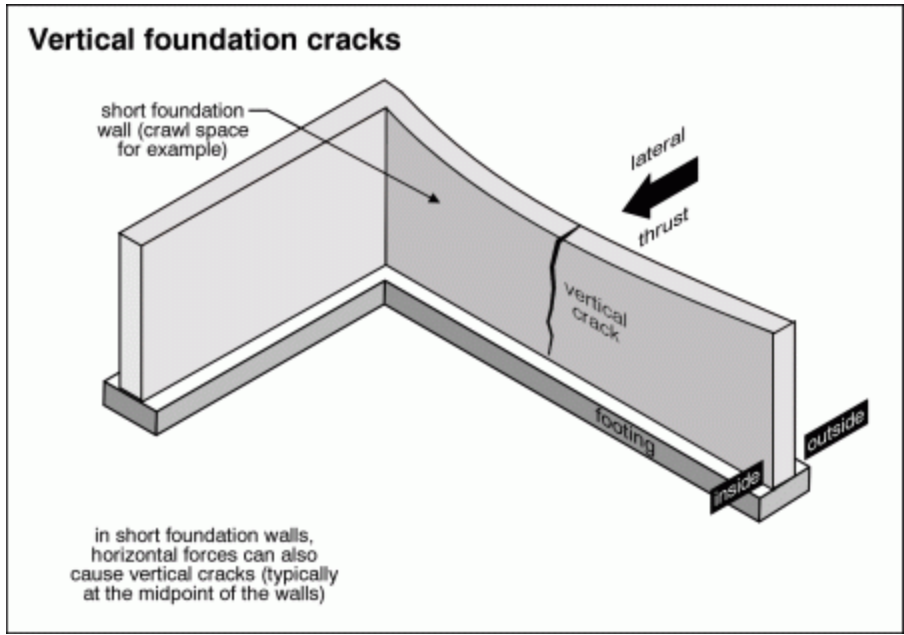
Additionally we observed some lateral displacement of the left side wall in the garage which we suspect may be caused by pressure from expansion of the backfill.

Approx 5mm of lateral displacement

We recommend having a pyrite test performed, the results will help determine the presence of pyrite and the potential for further damage.

Once that information is obtained an intervention by a foundation specialist will be required to seal and stabilize the cracks.

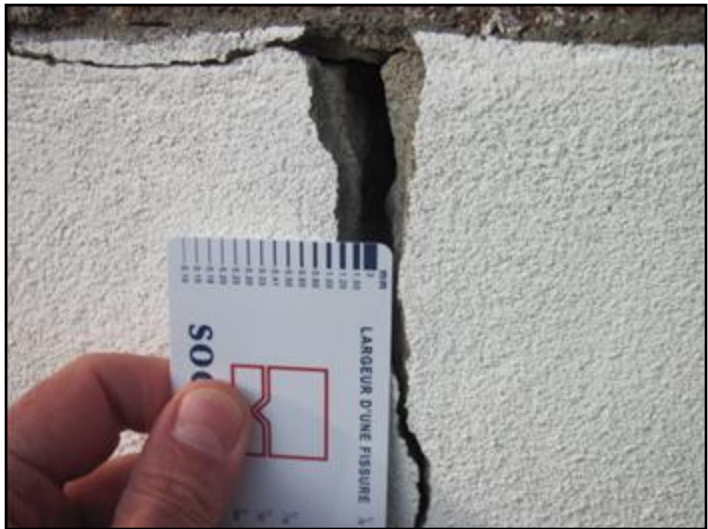
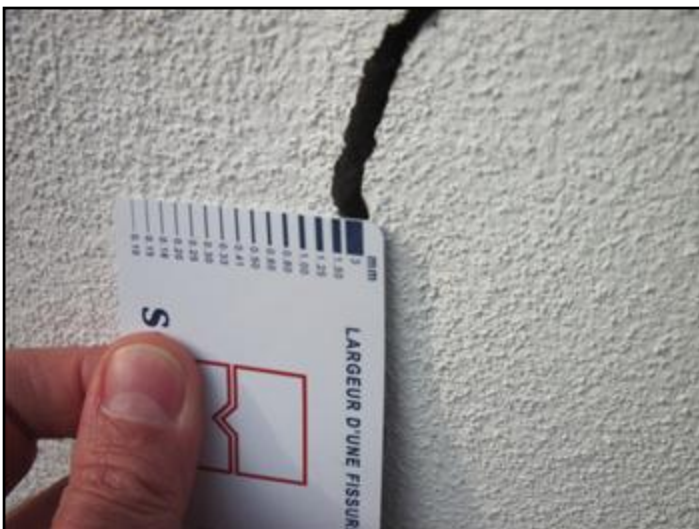
We noted two cracks in the foundation that suggest some differential displacement of the footings.

Crack in left wall exceeds 3mm

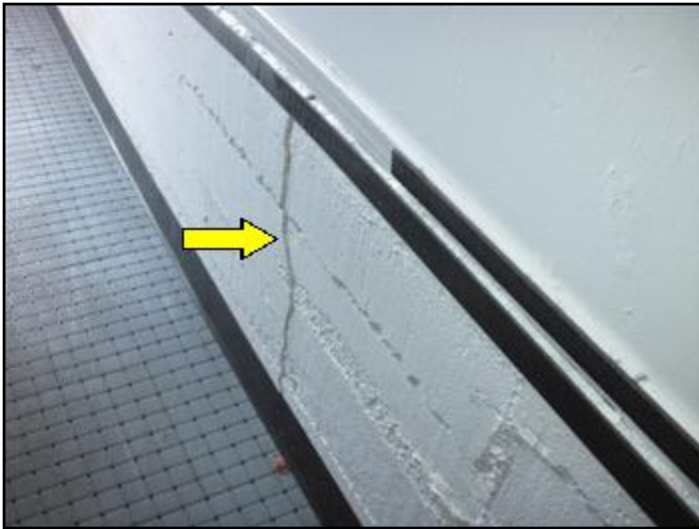
Left wall crack seen from inside

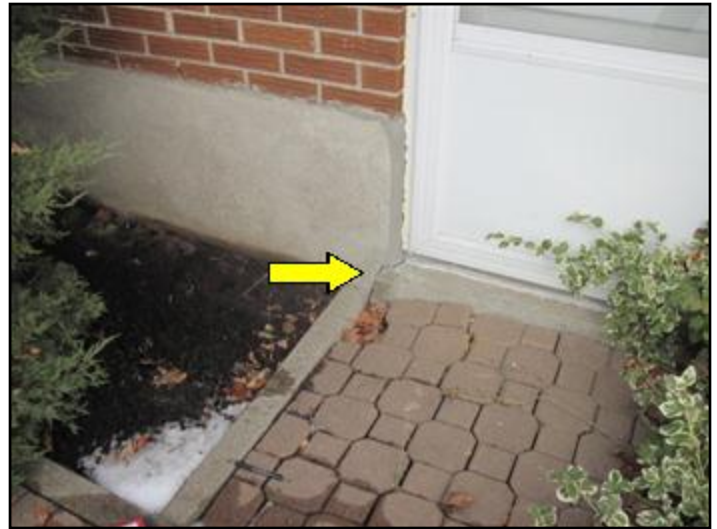
Crack in rear garage wall

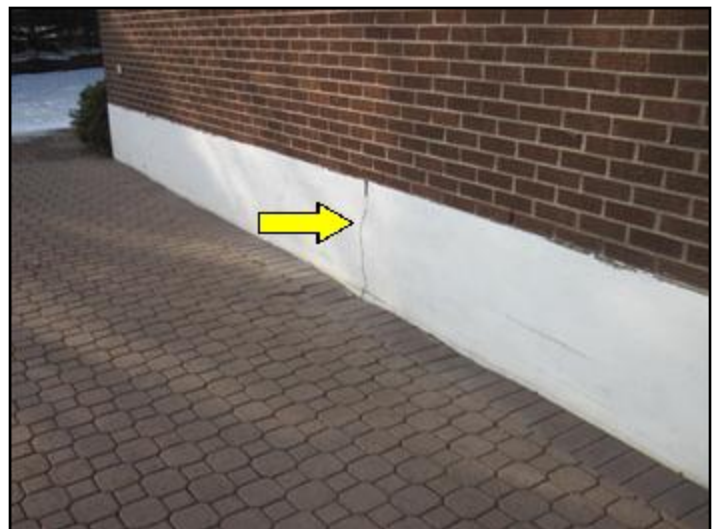
Crack in left side garage wall

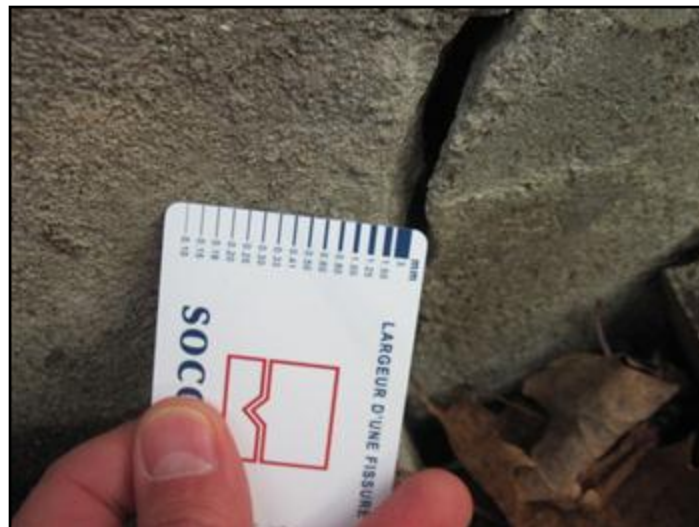
Crack in rear wall exceeds 3mm

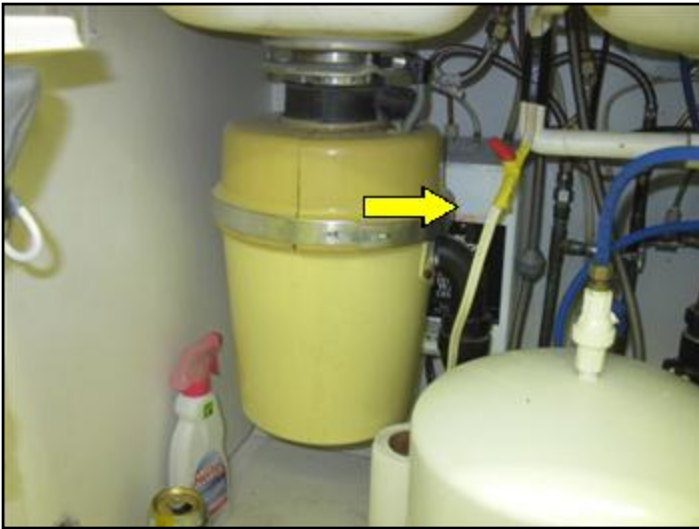
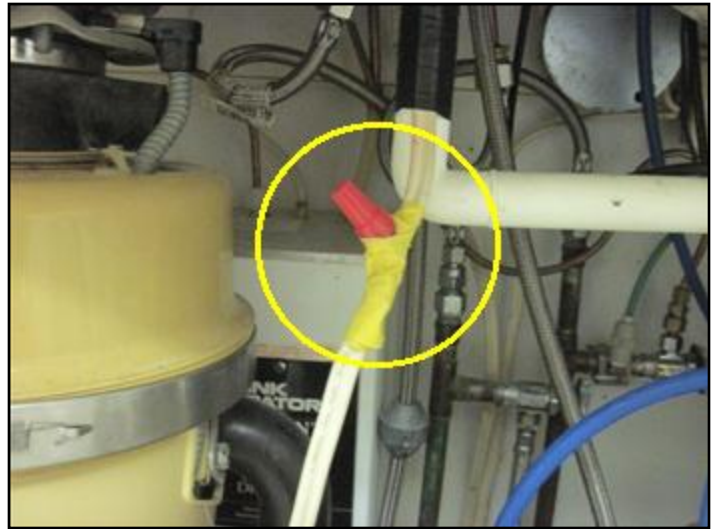
We noted an open splice that is not properly contained inside an electrical box.

Improper electrical connection

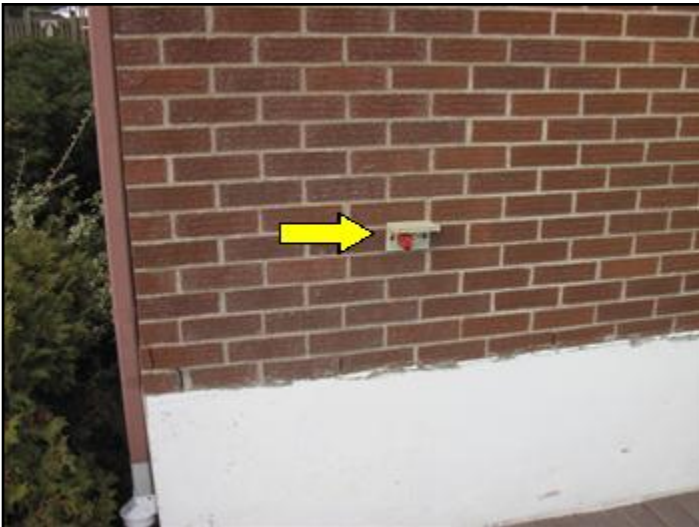
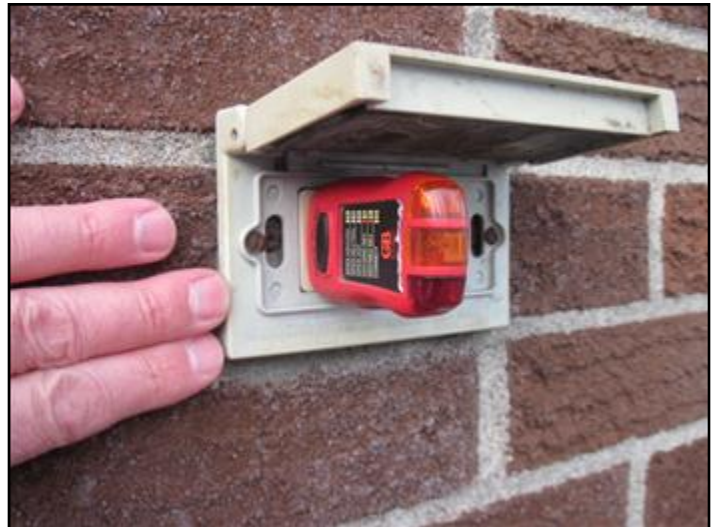
A test of the left exterior outlet indicates an open neutral condition.

Open neutral condition detected

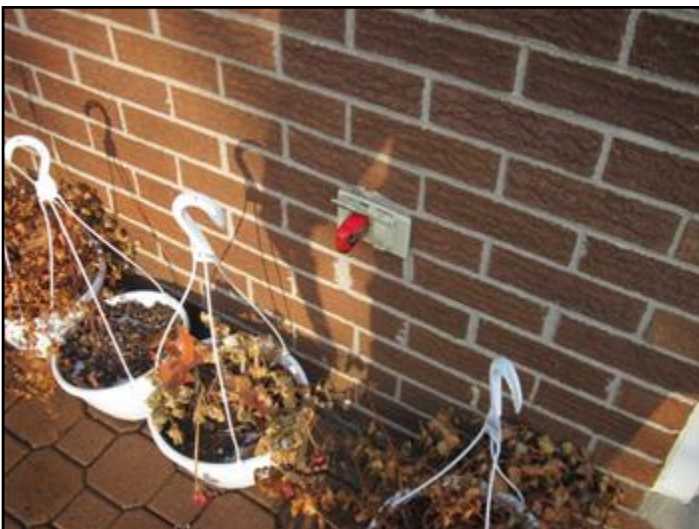
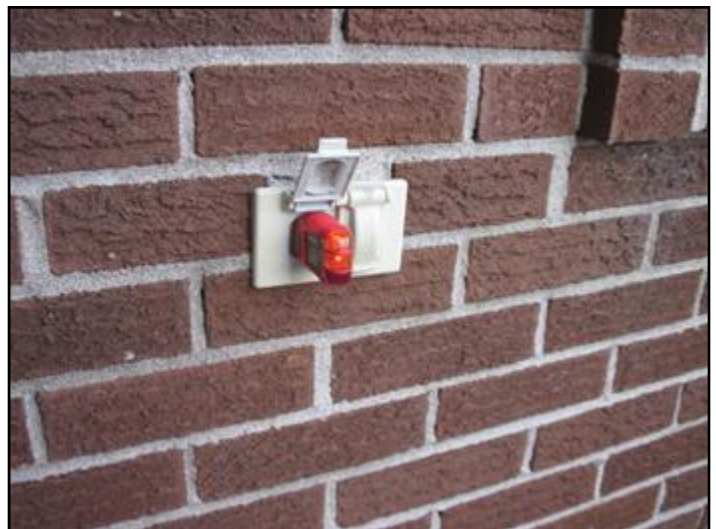
Several of the exterior outlets are missing ground fault protection.

Exterior outlet missing GFI protection

Recommend adding GFCI devices for added safety.

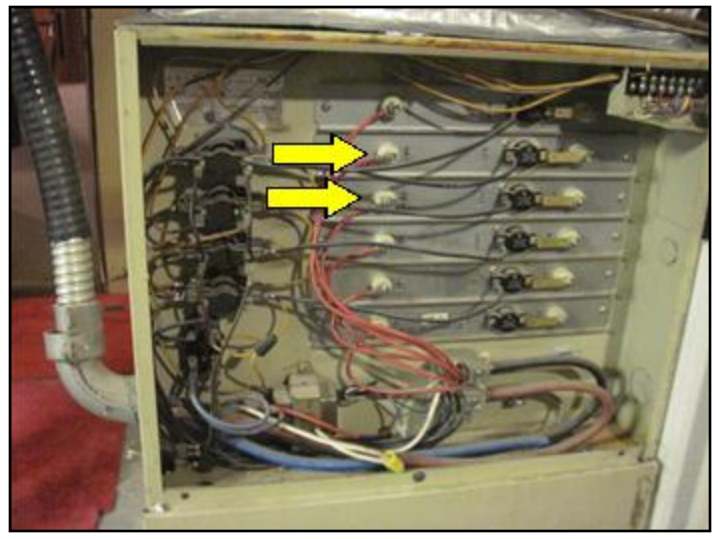
A test of the furnace revealed two heating elements are not operational and a third unit is not connected. Recommend having the system examined by a heating system technician.

Elements #2 & #3 not functional

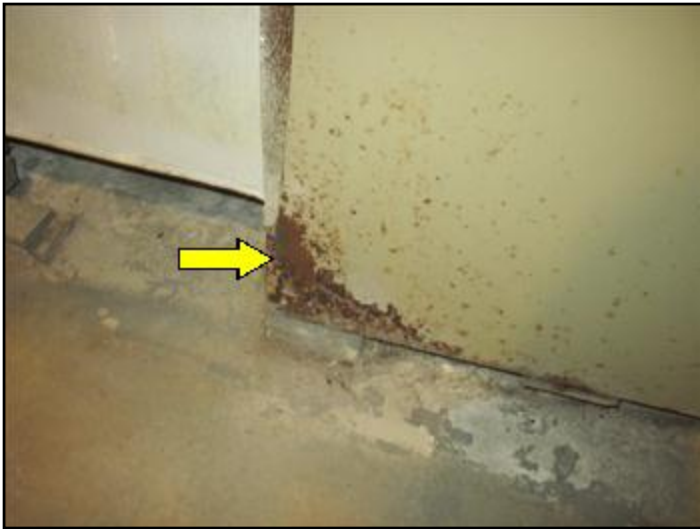
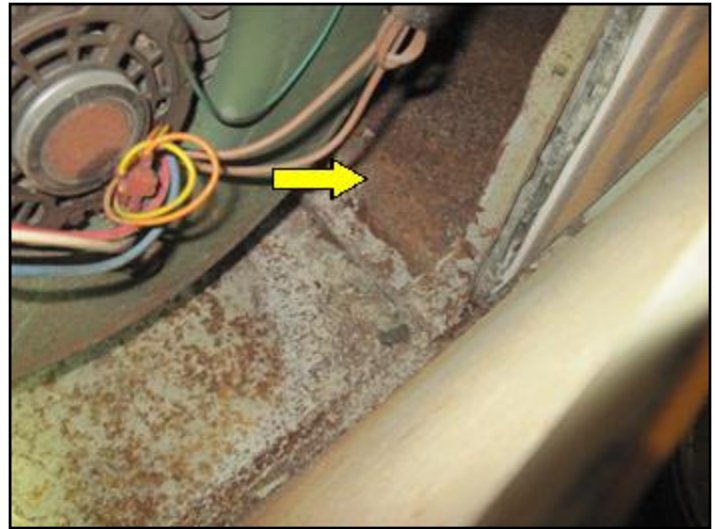
We noted a fair bit of rust inside the furnace cabinet. This is typically caused by water leakage from the humidifier or AC evaporator coil water pan. Recommend verifying both for potential leakage problems.

Rust exterior furnace cabinet

Rust inside furnace cabinet

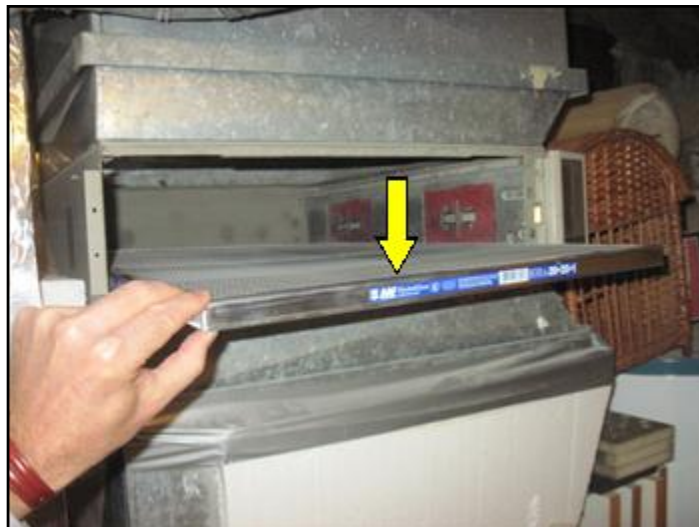
We noted the electronic air cleaner is no longer functional and has been replaced with an electrostatic air filter. This filter should be cleaned on a monthly basis for optimal performance.

Electrostatic air filter

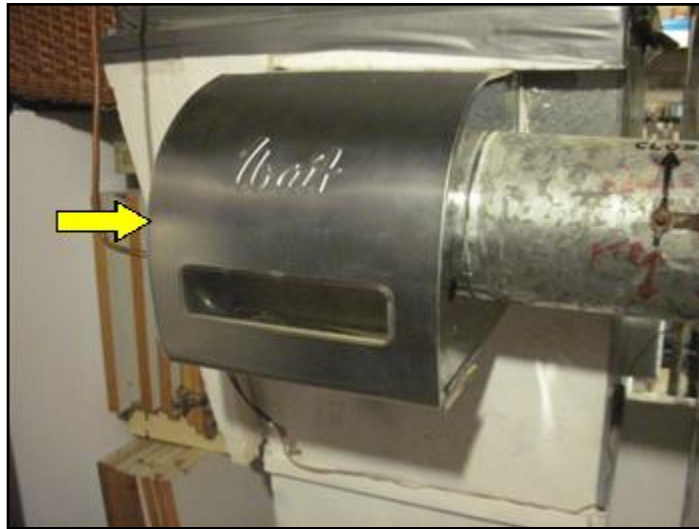
Clean drum humidified regularly

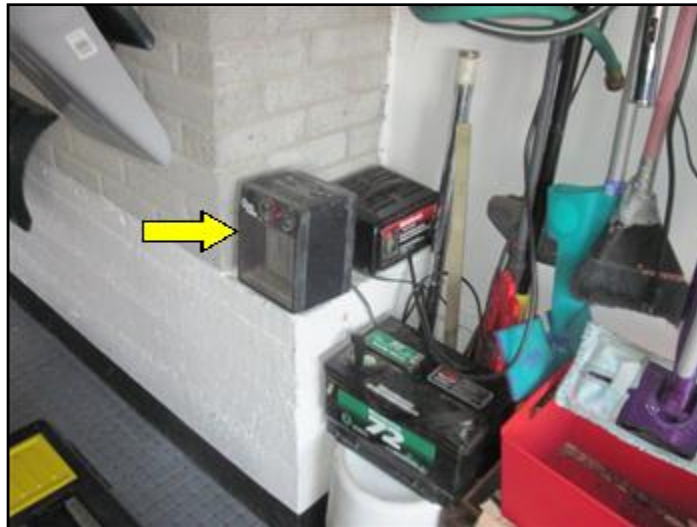
We noted the garage is not equipped with a permanent heat source.

Heat source inadequate for the garage

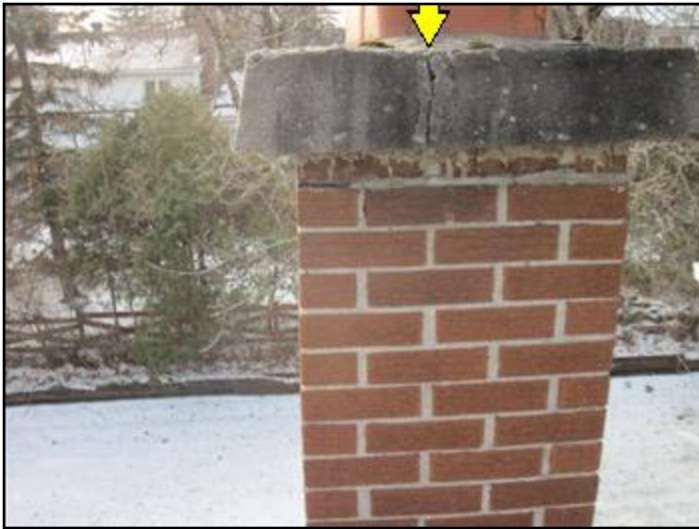
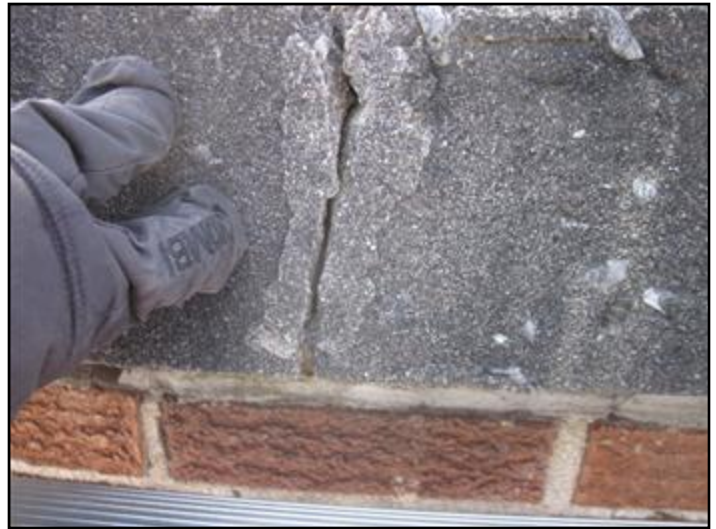
We noted the chimney cap is cracked and should be repaired before it deteriorates further and requires replacement.

Chimney cap cracked

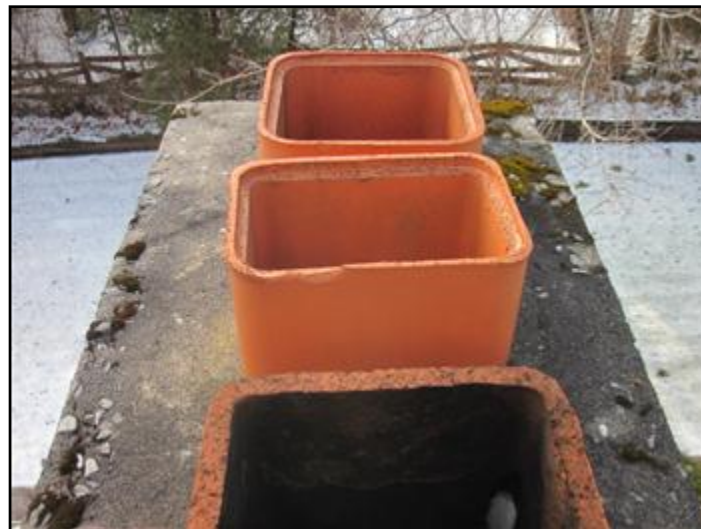
Rain caps and screens missing

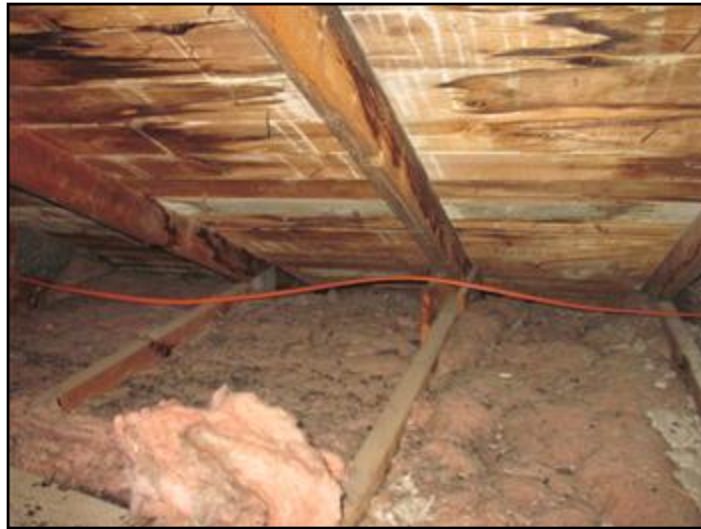
Limited insulation in garage attic

Recommend improving the insulation in the space taking care not to block the airflow inside the attic coming from the soffits.

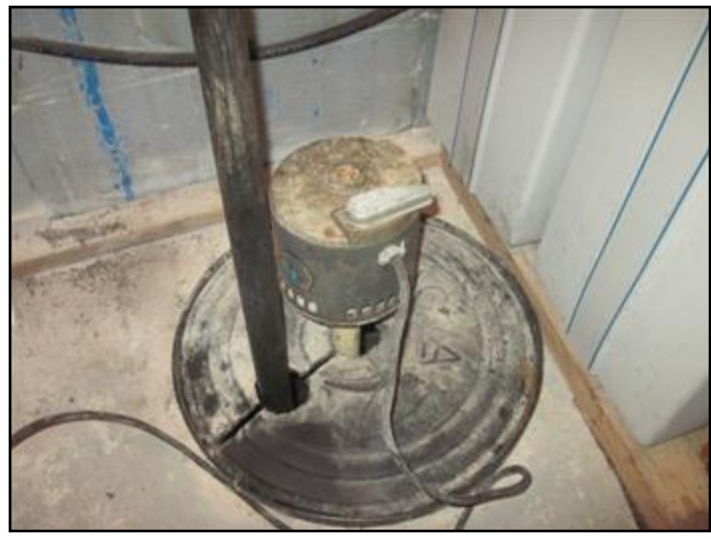
We suspect that the reason for this may be the condition of the french drain system.

Sump pump not functional

Recommend further investigation of the french drain to determine its condition.

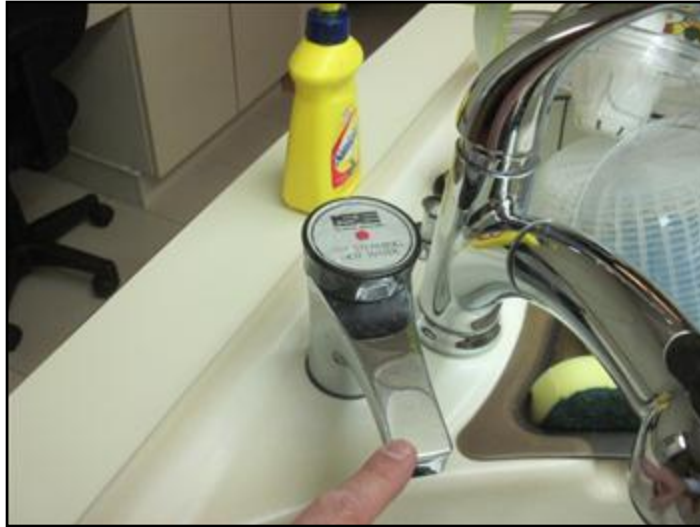
Hot water dispenser not functional

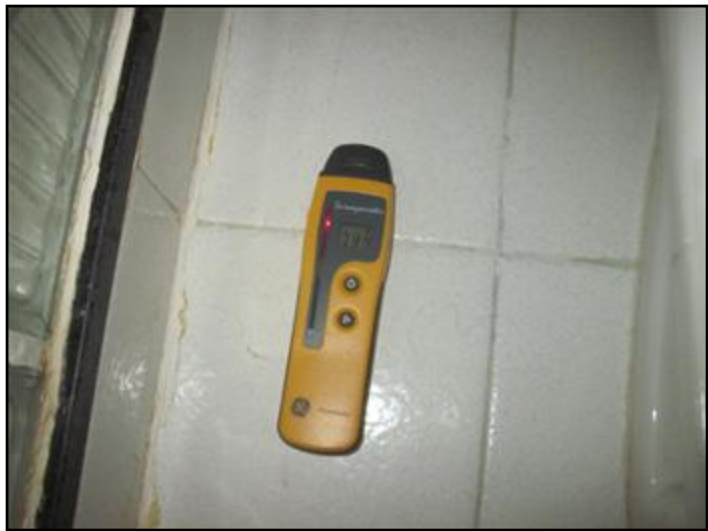
During our scan of the bathrooms we discovered higher than normal moisture levels under the ceramic floor between the shower and the toilet of the ensuite bathroom.

This suggests water leakage either from the shower stall or from the toilet.

High moisture level detected under ceramic

Further evaluation is recommend to identify and correct the source.

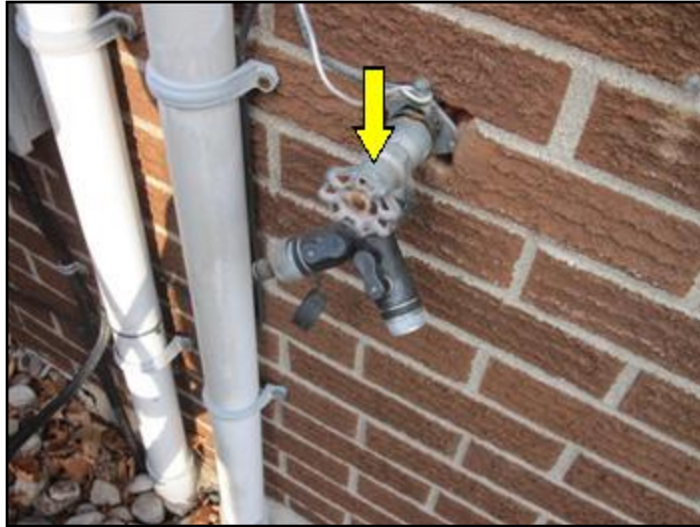
The rear hose bibb is missing a backflow prevention device. This can allow contaminated water to be siphoned back into the system.

Backflow missing on hose bibb

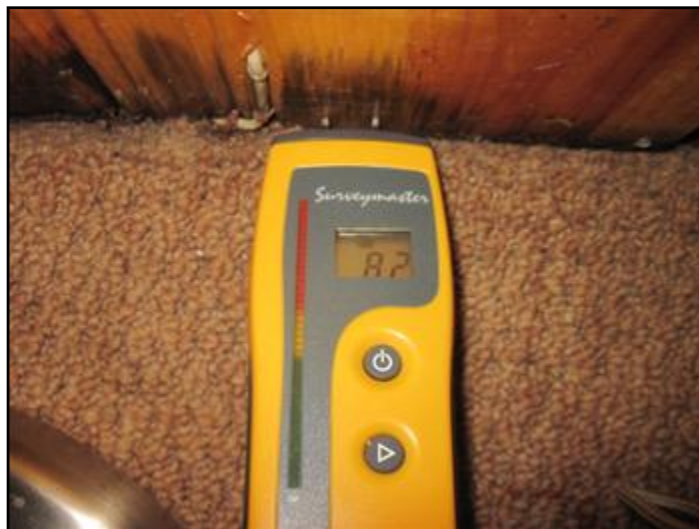
Evidence of water infiltration was present in the basement. It coincides with the windows where we noted the window wells were not appropriately designed/installed.

Tests were performed using various equipment to detect moisture presence, the results indicate levels slightly above normal but no recent or active water infiltration.

Testing for moisture in basement

Although we could not detect any sign or symptom of mold spores we suggest the wall covering be removed to evaluate potential mold presence and if necessary remediation measures taken including work on the exterior window wells (see notes in EXTERIOR section).

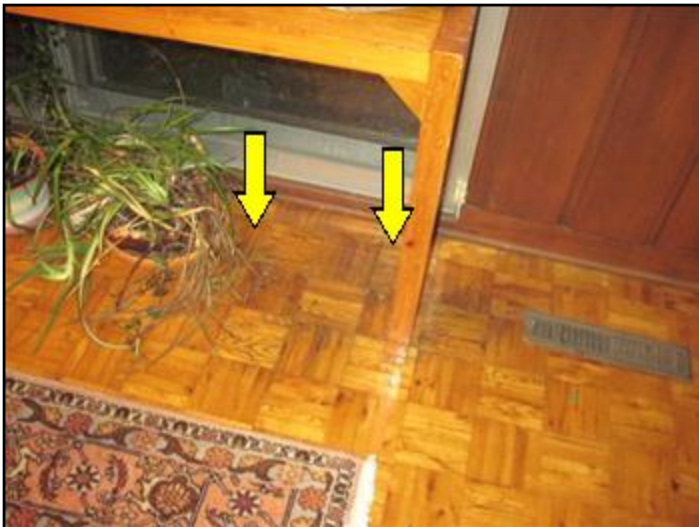
We noted some evidence of water damage of the floor covering near the sliding glass doors in the dining room. We tested the area with an Extech M0290 Hygrometer and did not detect any abnormal moisture levels or indication of active or recent water infiltration.

Water damage to floor covering

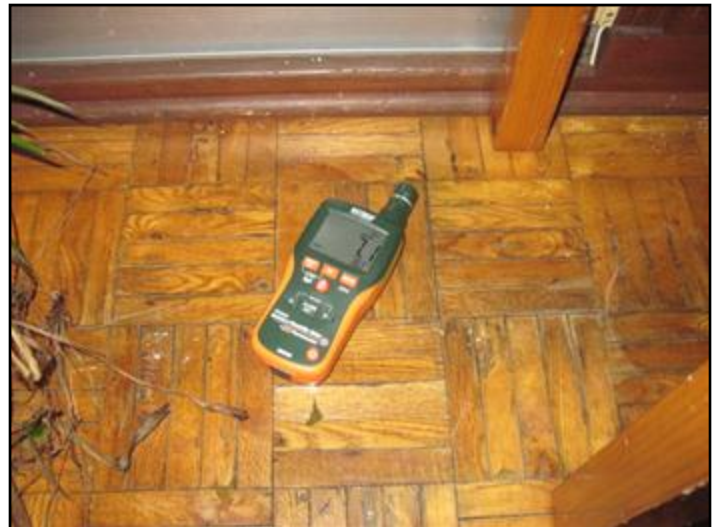
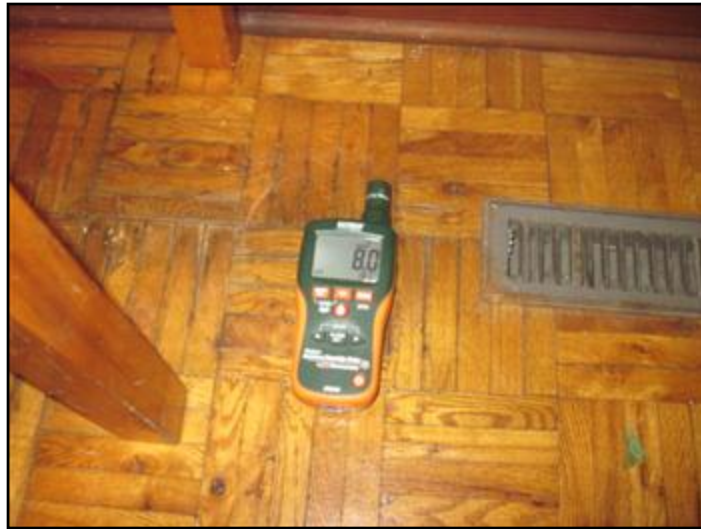
Test indicates normal moisture level

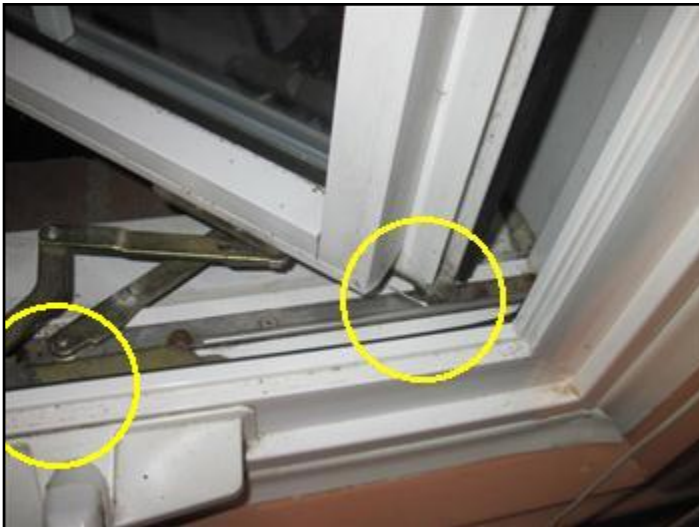
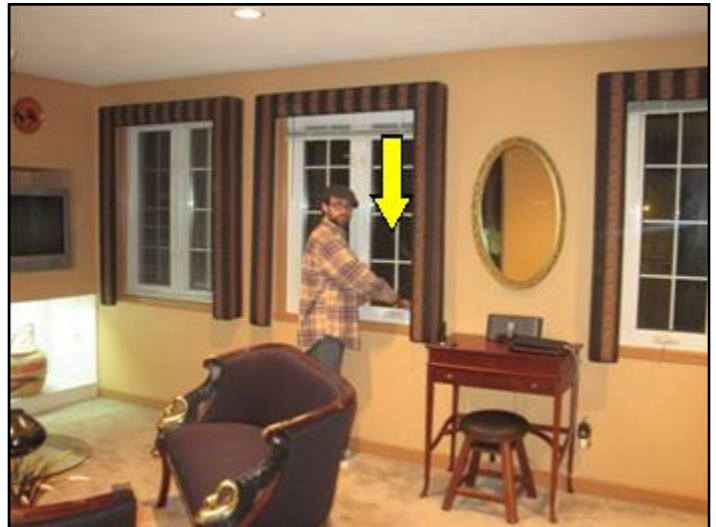
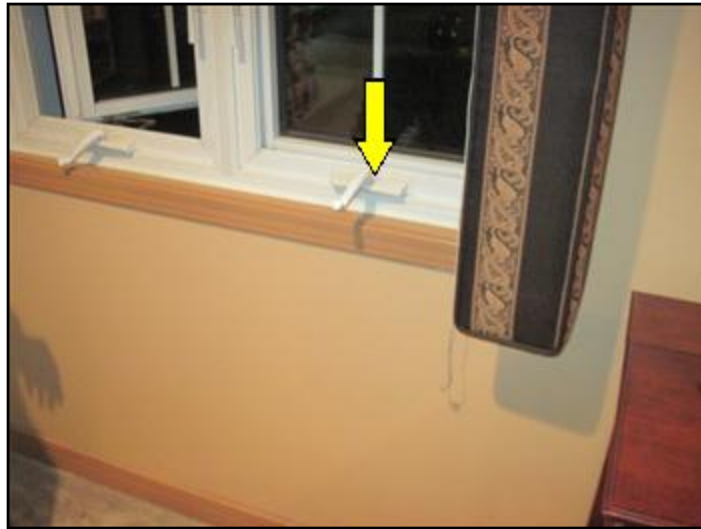
During our inspection of the windows we found one of the window mechanisms to be broken. Recommend having the window repaired to allow for proper operation and ensure a weather tight seal.

Damaged hardware in need of replacement

Window repair needed in master bedroom

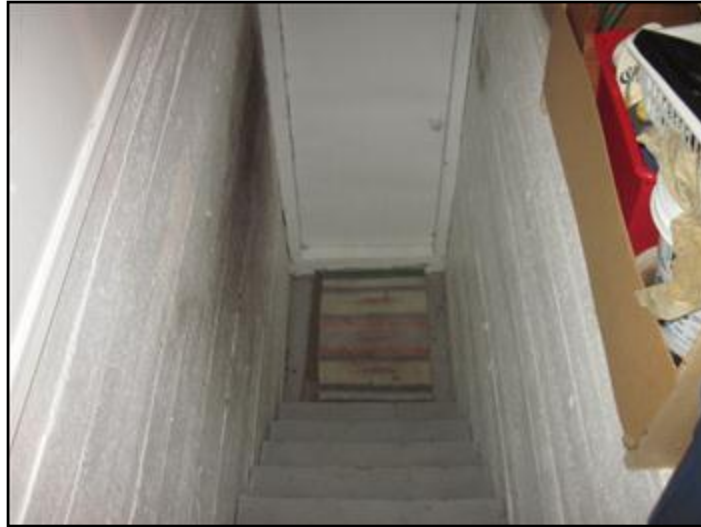
We noted a handrail is missing in the staircase leading to the basement. One should be added for safety reasons.

Handrail missing in staircase

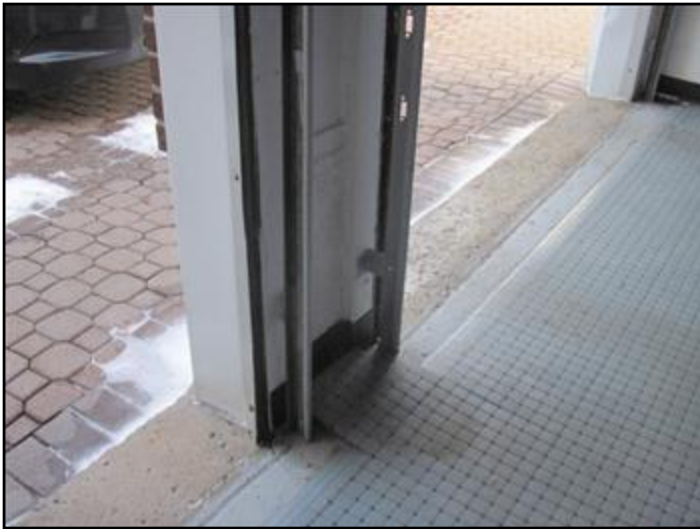
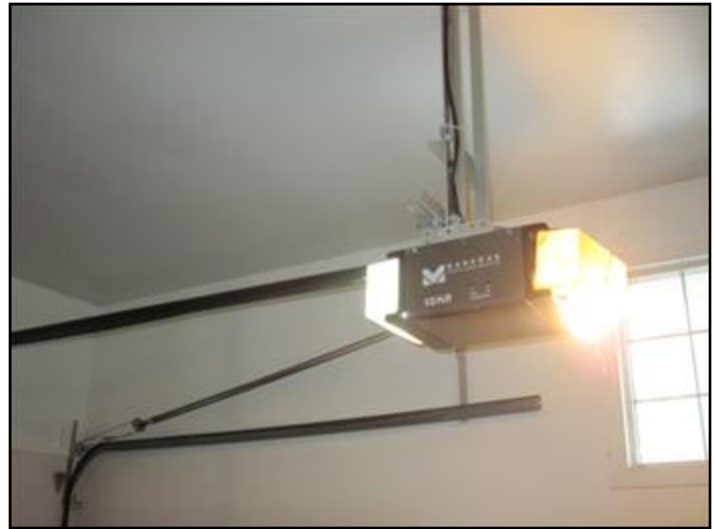
A test of the garage door openers revealed the devices are lacking proper safety devices and fail to auto reverse. Recommend replacing the units for safety reasons.

Infrared sensors missing on GDO's

Garage door openers fail test on auto-return

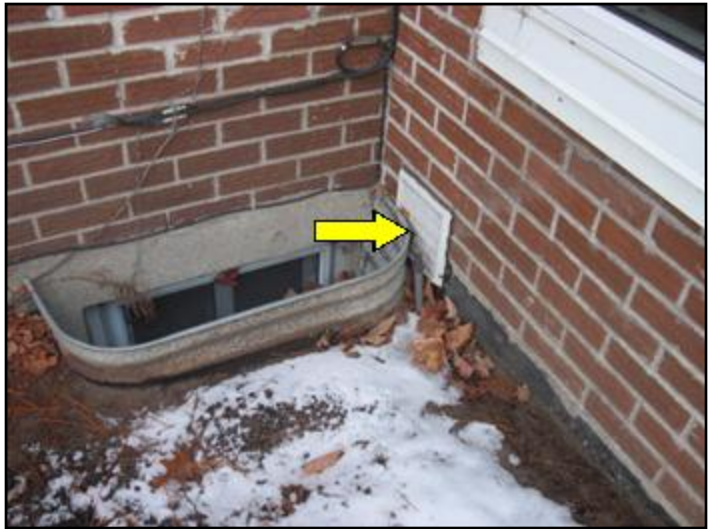
Bathroom vent hood blocked

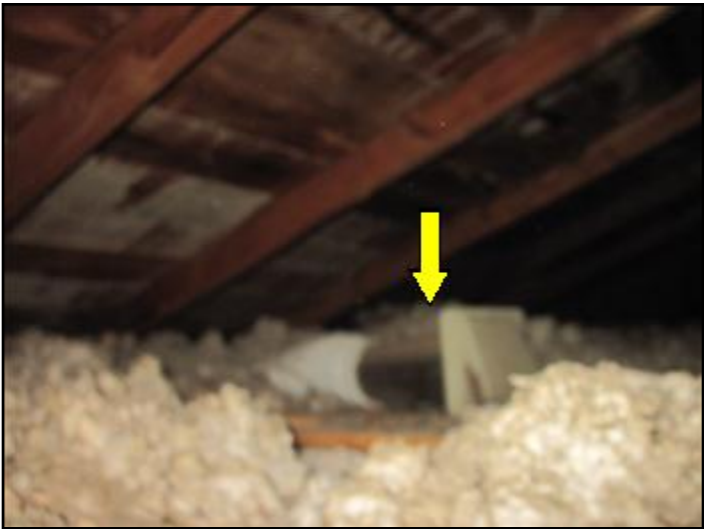
We found a bathroom exhaust fan duct venting in the attic. This does not conform to proper installation procedures and can lead to condensation problems in the attic. All venting through the attic must be done inside an insulated duct and be vented outside the building.

Inappropriate venting inside the attic

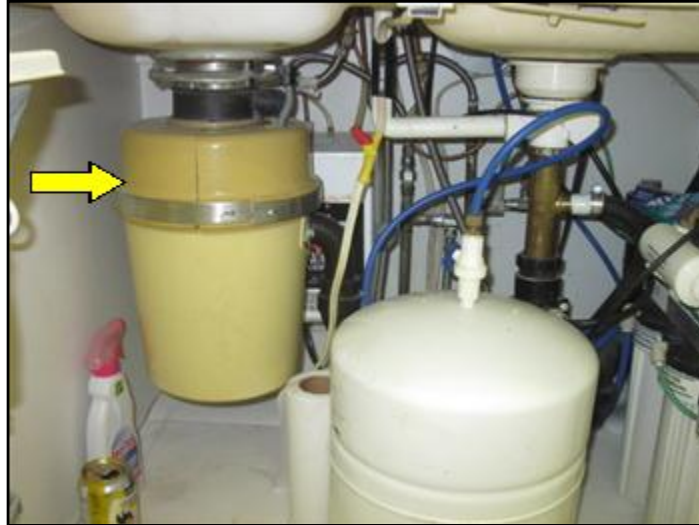
Garborator not functional
