# Your Inspection Report

107 - 5th Avenue  
Montreal, QC

RE: Report No. 1358, v.2  
107 - 5th Avenue  
Montreal, QC

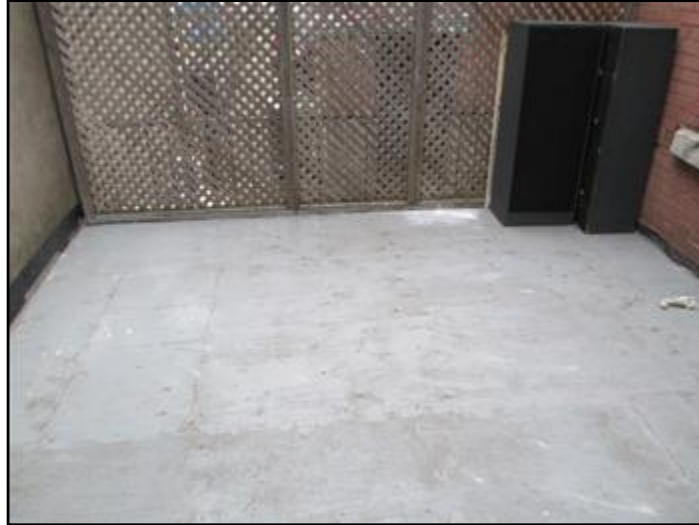
A secondary roof membrane is installed over an extension built at the rear of the building. That membrane could not be examined as it is covered by a wood deck.

*Secondary roof at rear covered by wood deck*

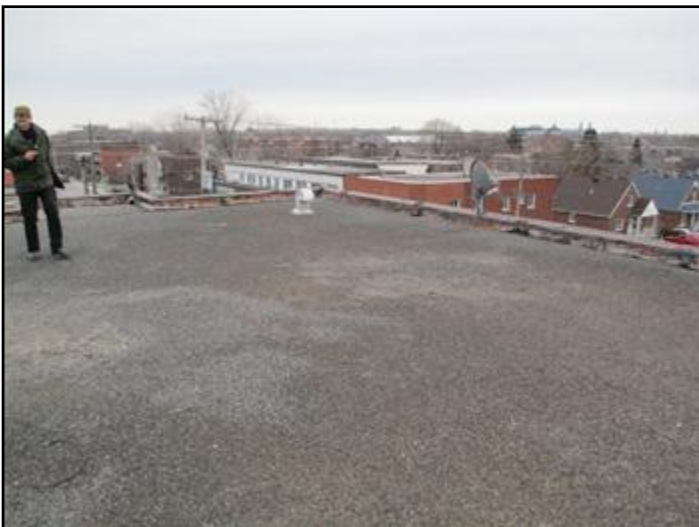
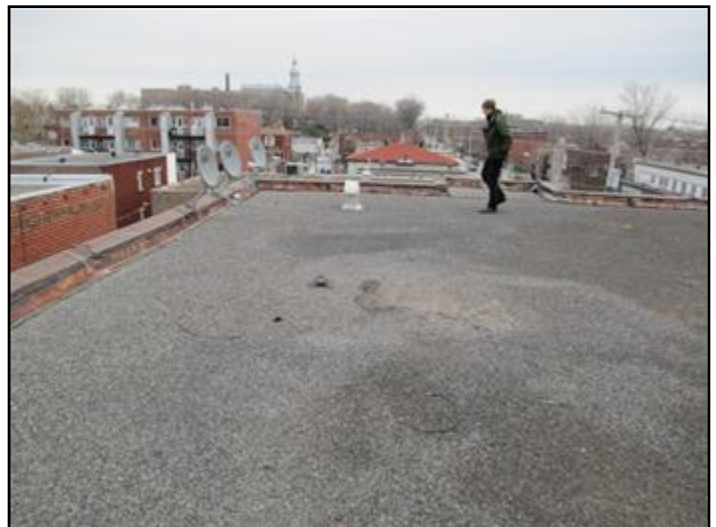
Although we found no signs of active water infiltration we recommend replacing the roof covering within the next two years.

Partial view of roof towards the front

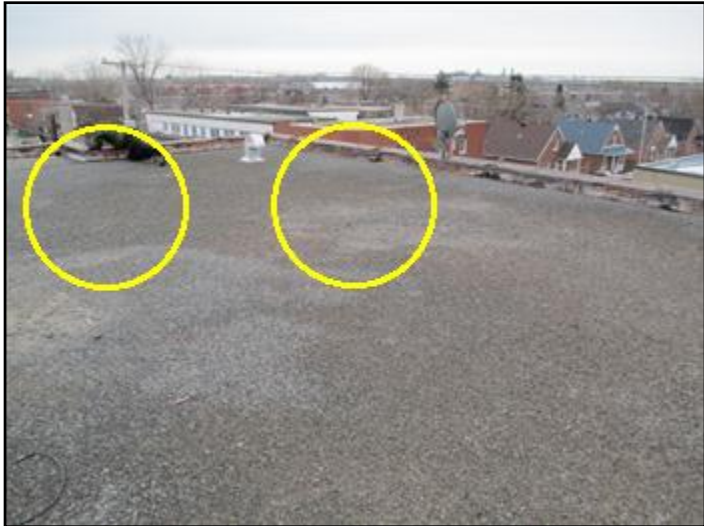
This can cause accelerated wear on the membrane due to ice erosion as well as excess weight build-up on the structure. Recommend the slope be corrected when replacing the roof membrane.

*Symptoms of water ponding visible*

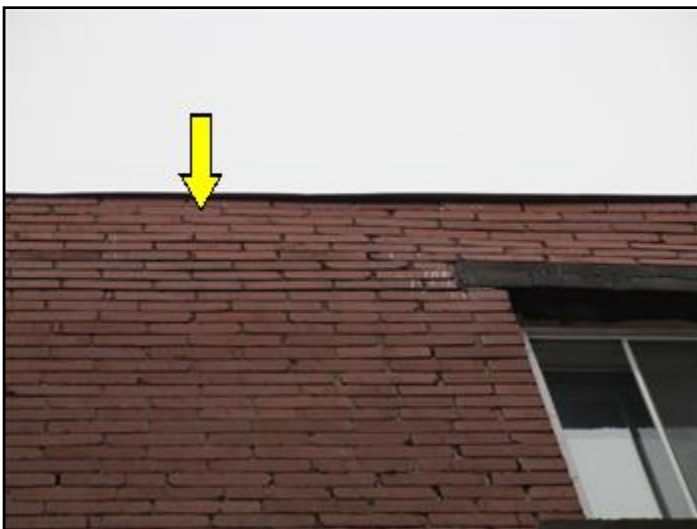
We noted the brick masonry on the right wall has begun to wave and to pull away near the top of the wall.

This poses a safety risk and should not be left unattended, temporary anchors may be required until proper repairs are completed.

*A bulge has appeared in top section of wall*

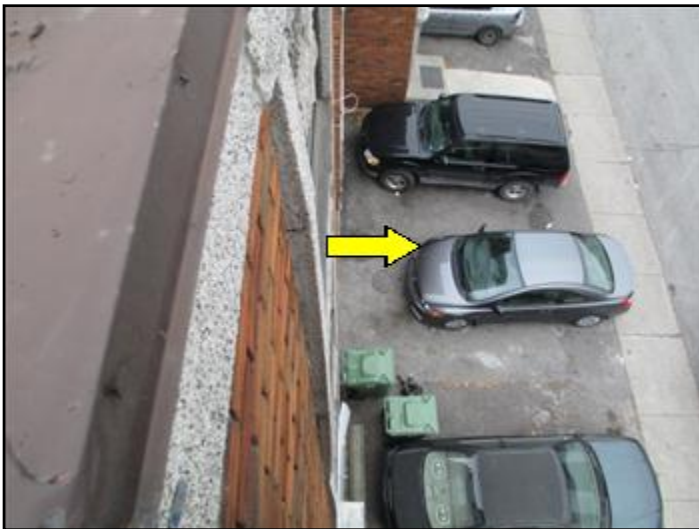
Also most of the front pre-cast decorative masonry elements are cracked and/or pulling away from the structure.

*Pre-cast masonry pulling away*

These should be replaced at the same time as the masonry work is done on the right wall.

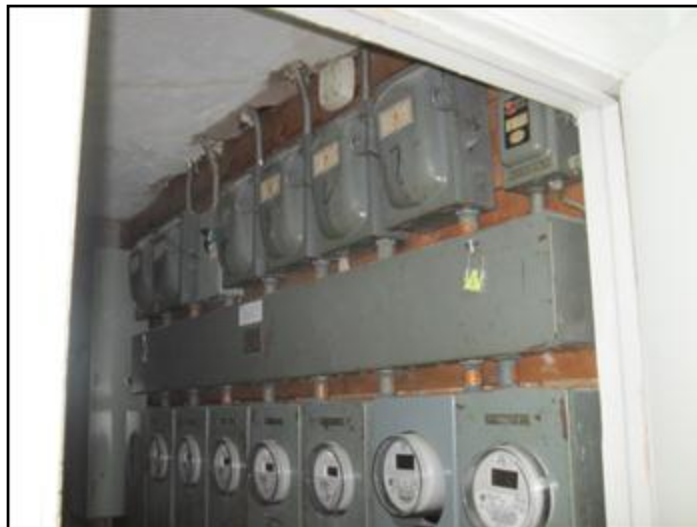
No defects or anomalies visible.

*Main electrical room at top of third floor*

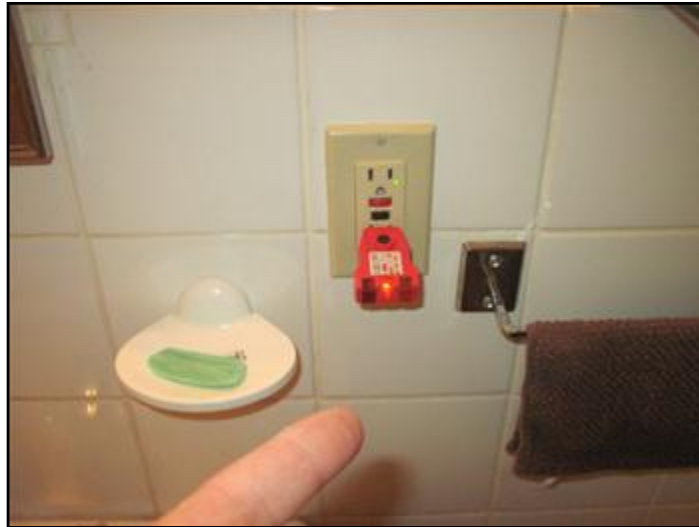
*Bathroom outlets not grounded*

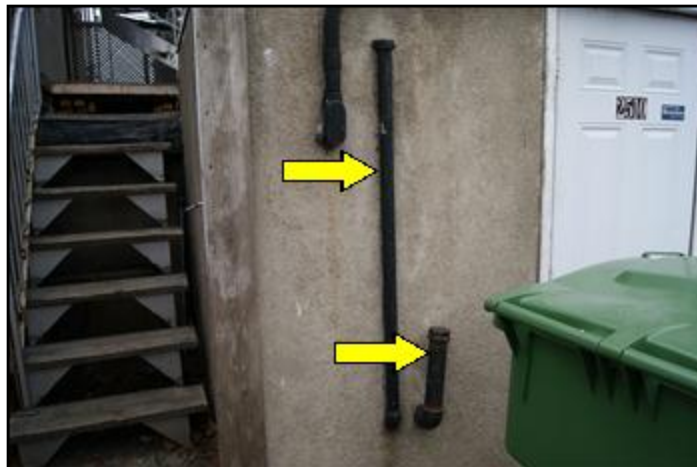
*Oil fill pipes on left exterior wall at rear*

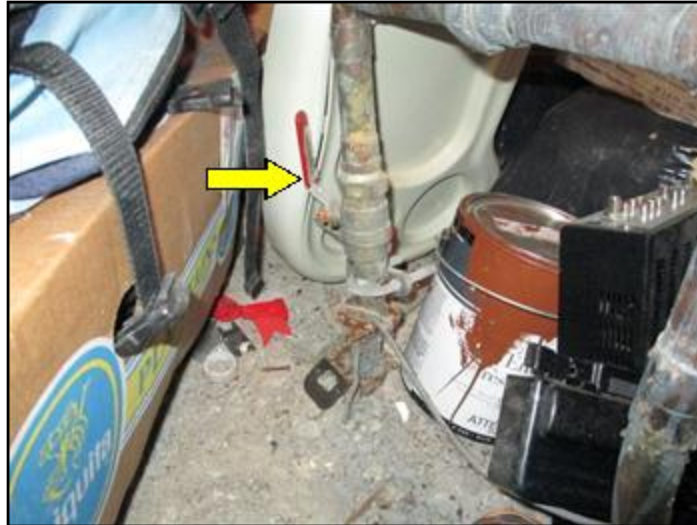
No defects or anomalies visible.

*Water main for building under front entrance*

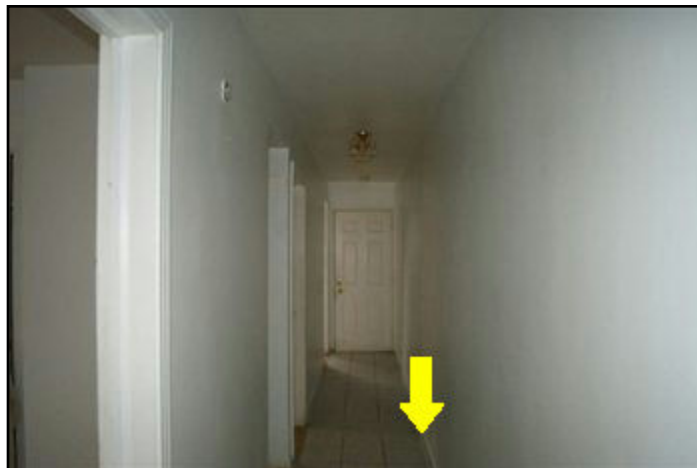
*Floor sloped towards center wall in apt 7*

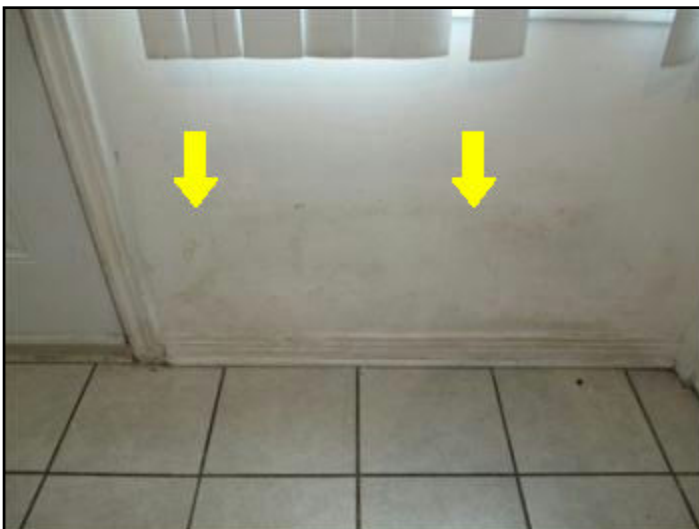
Problems visible with rear wall # 3
