Your Inspection Report

3142 Cannondale Ave
Montreal, QC

INSPECTION DATE:
Thursday, December 13, 2012

RE: Report No. 1360
3142 Cannondale Ave
Montreal, QC

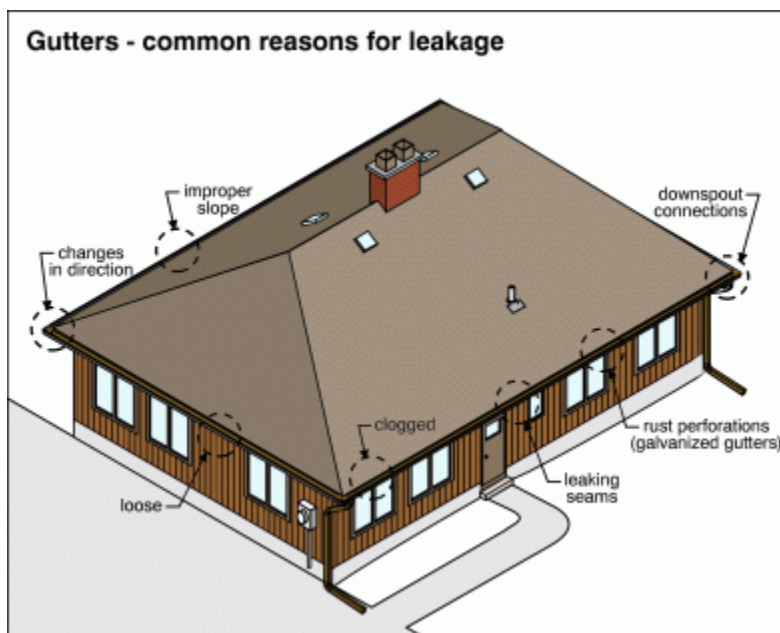
Condition: • [Clogged](#)

We noted the rear roof gutter was leaking, during our visit on the roof we noted it is clogged and needs to be cleaned.

Rear gutter clogged and leaking

Task: Clean

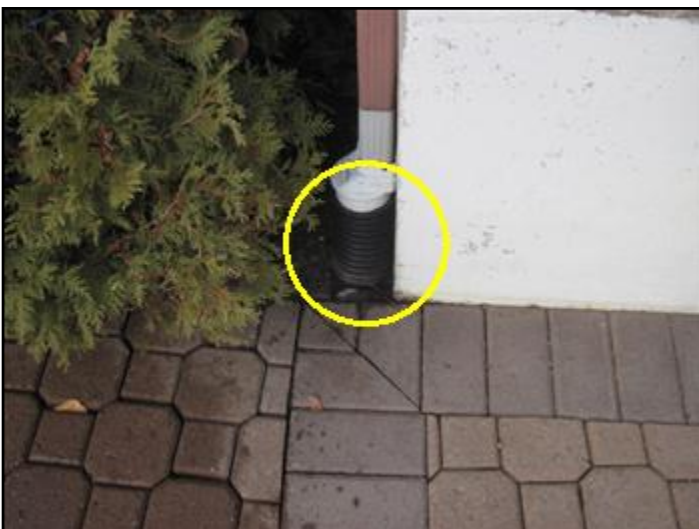
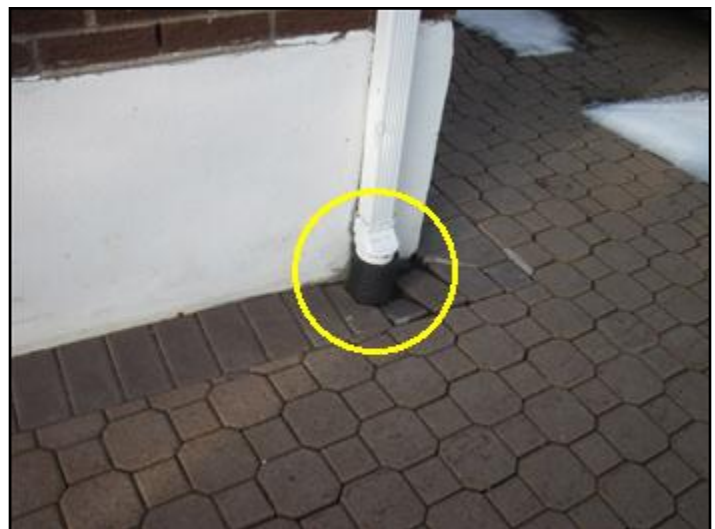
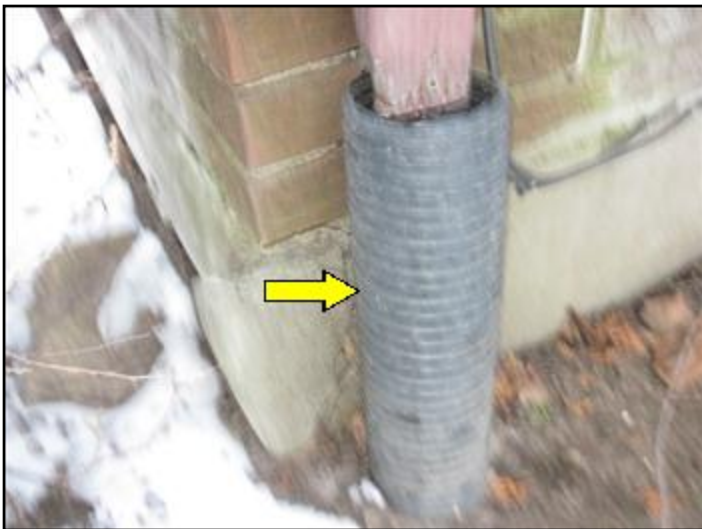
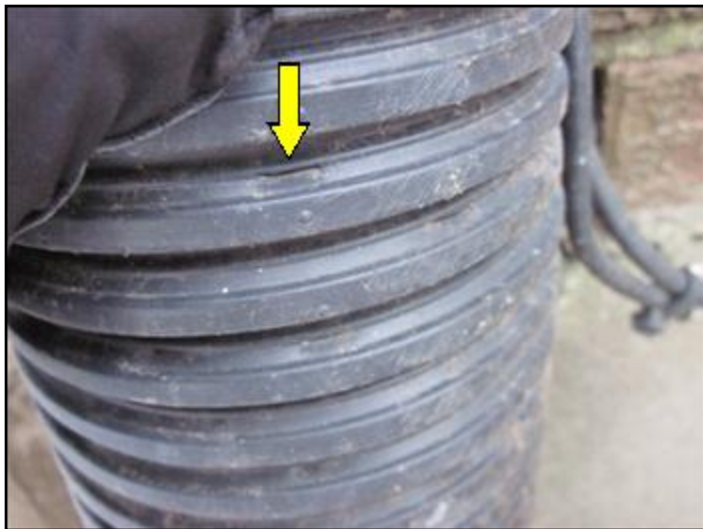
However we noted that the type of pipe used is inappropriate as it is perforated and allows most of the water to drain out next to the foundation.

Perforated pipe used

Recommend replacing a section of at least 6 feet with non perforated pipe to carry the water far enough away from the house.

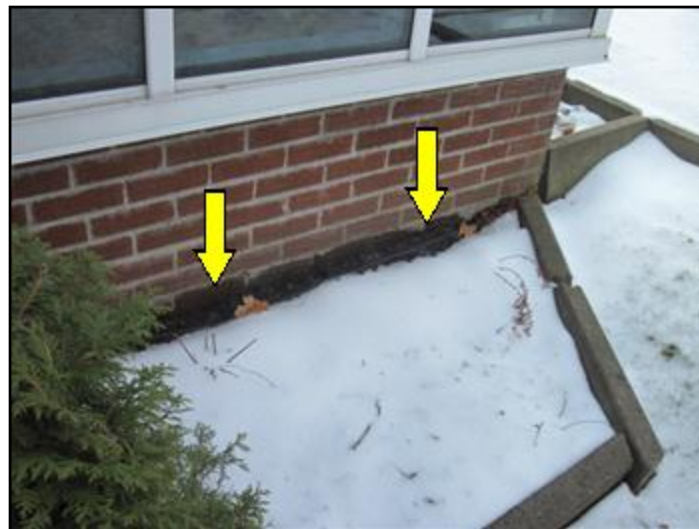
Condition: • [Too close to grade](#)

We noted the lot grading at the rear and on the right side of the building is too close to the masonry. This can cause moisture problems for the masonry elements and the wood frame structure. See prescribed guidelines shown.

Masonry too close to grade

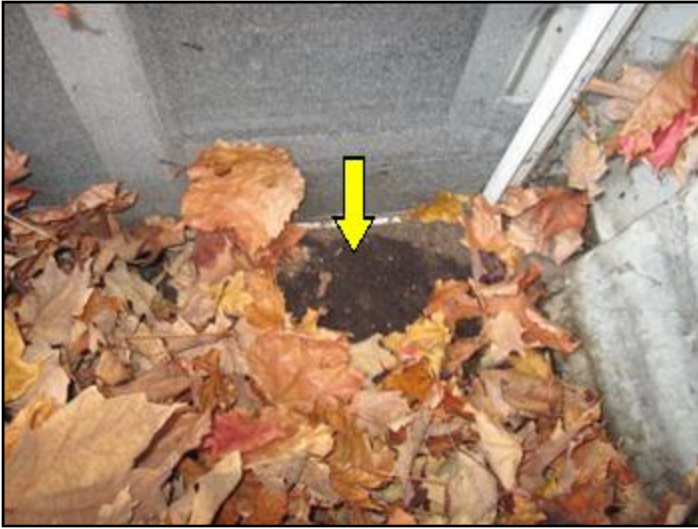
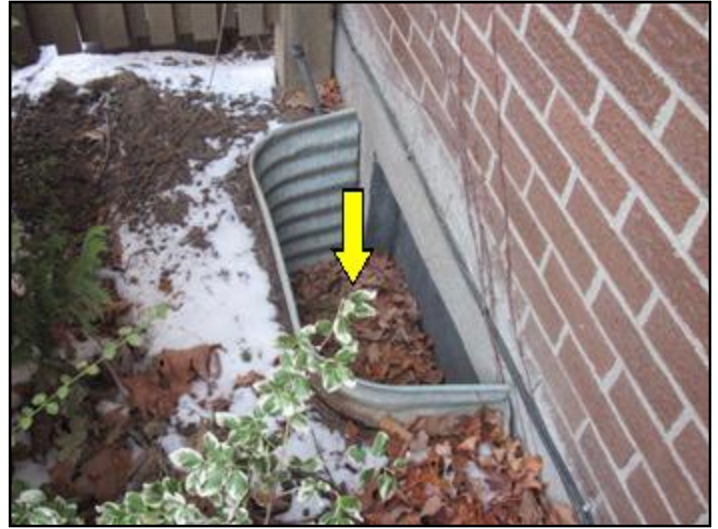
Condition: • [Wood/soil contact](#)

The ground is coming up too high which in turn is allowing water to leak into the basement through the window opening (see notes in the INTERIOR section).

The ground is all the way up to the window

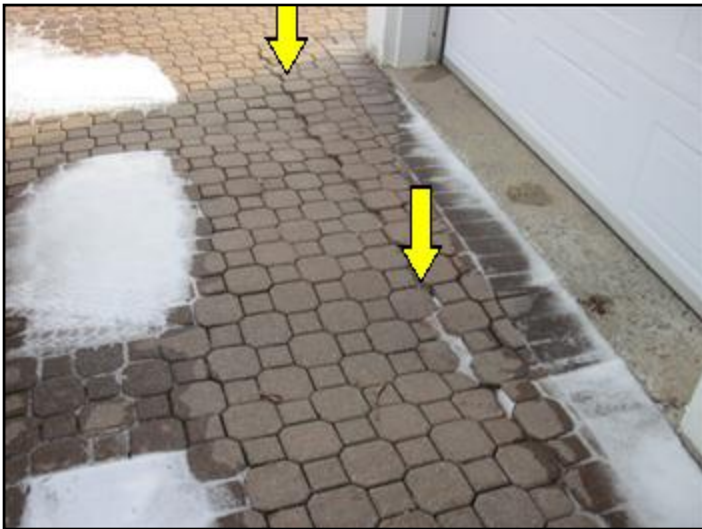
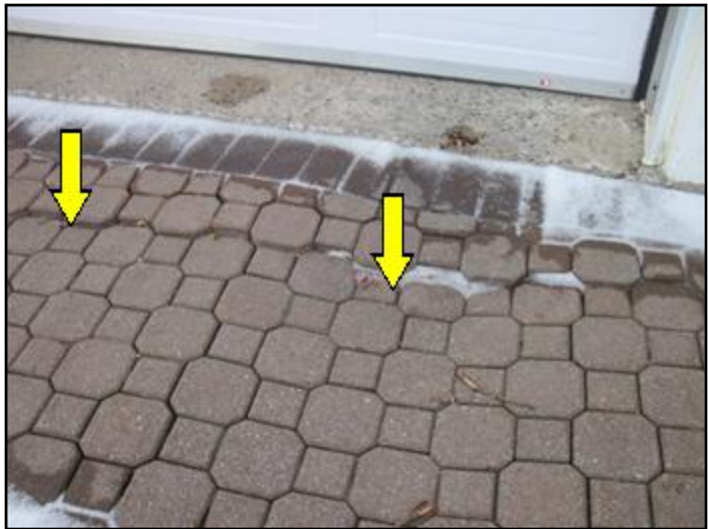
Excessive settlement in driveway

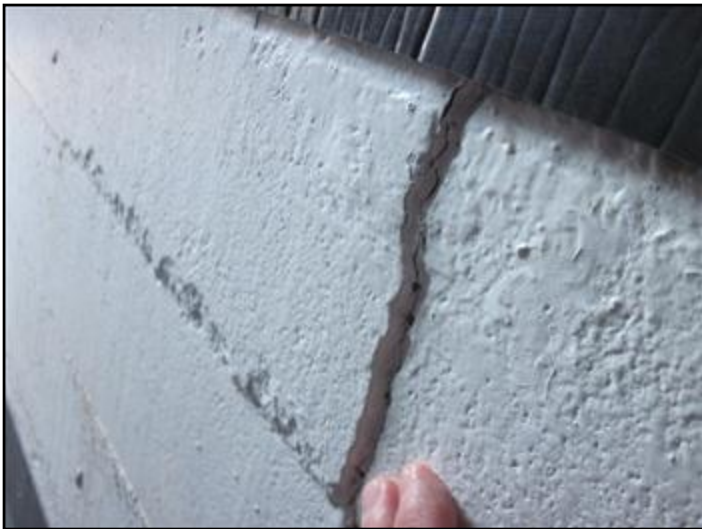
Additionally we observed some lateral displacement of the left side wall in the garage which we suspect may be caused by pressure from expansion of the backfill.

Approx 5mm of lateral displacement

We recommend having a pyrite test performed, the results will help determine the presence of pyrite and the potential for further damage.

Once that information is obtained an intervention by a foundation specialist will be required to seal and stabilize the cracks.

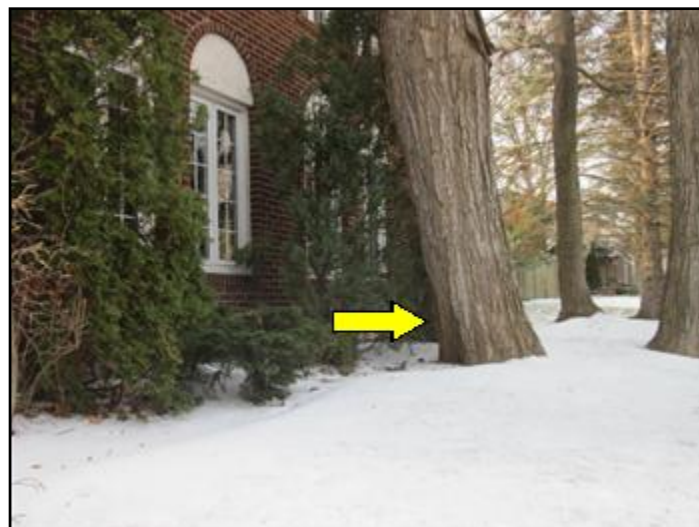
Large tree less than 2 metres from house

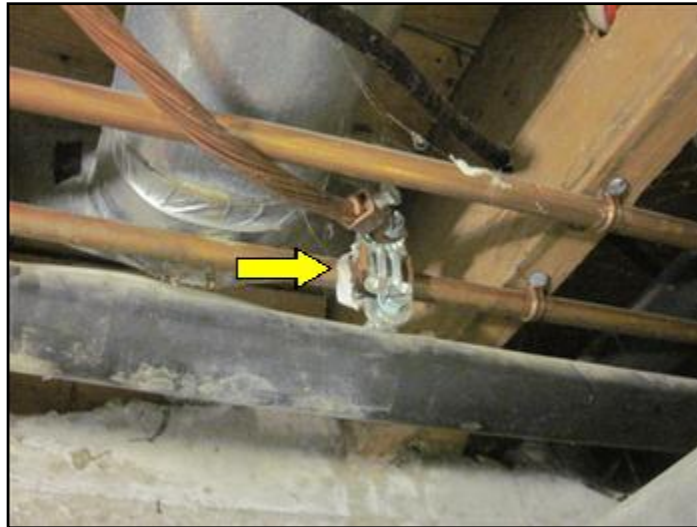
Inappropriate ground connection

Task: Correct

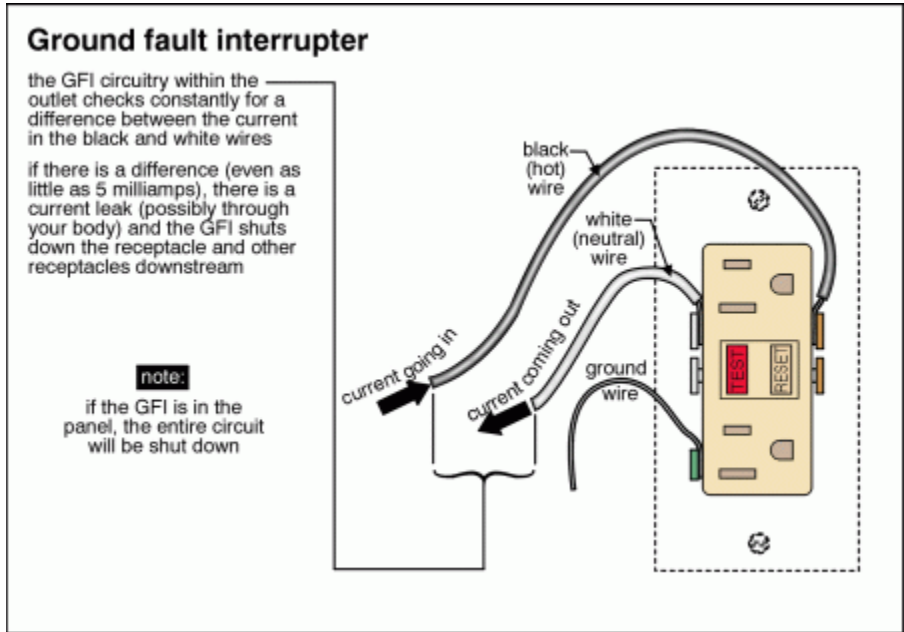
Exterior outlet missing GFI protection

Task: Provide

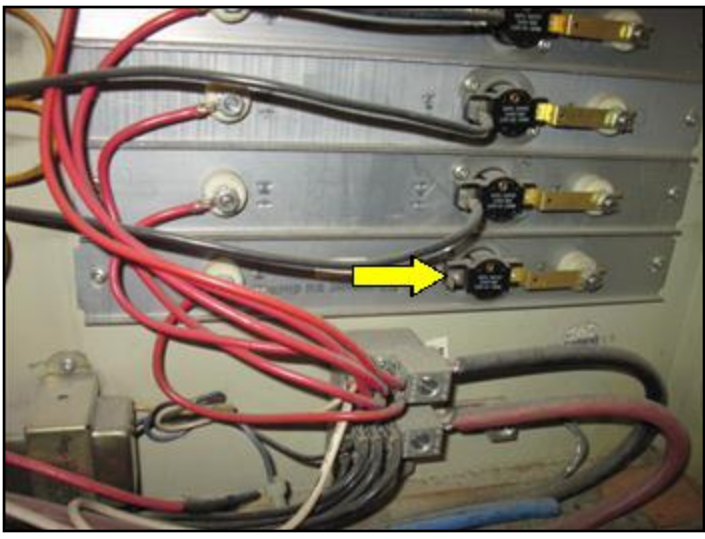
Element #6 not connected

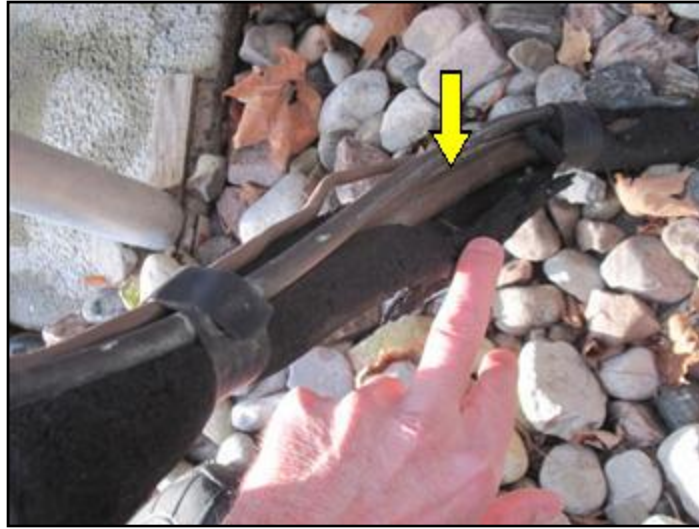
Exposed refrigerant line

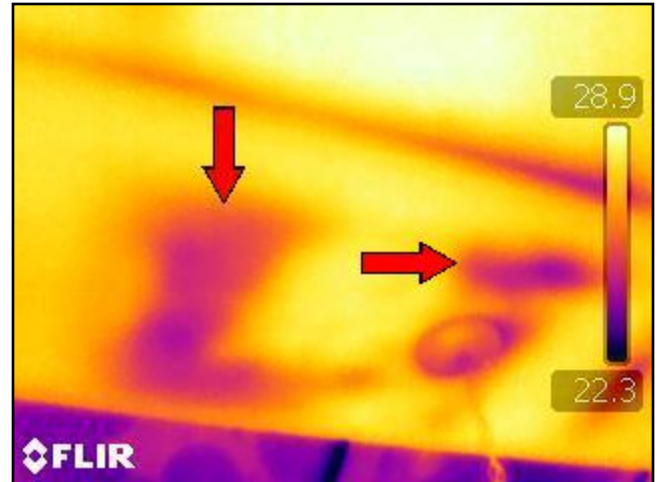
Temperature variations visible in ceiling

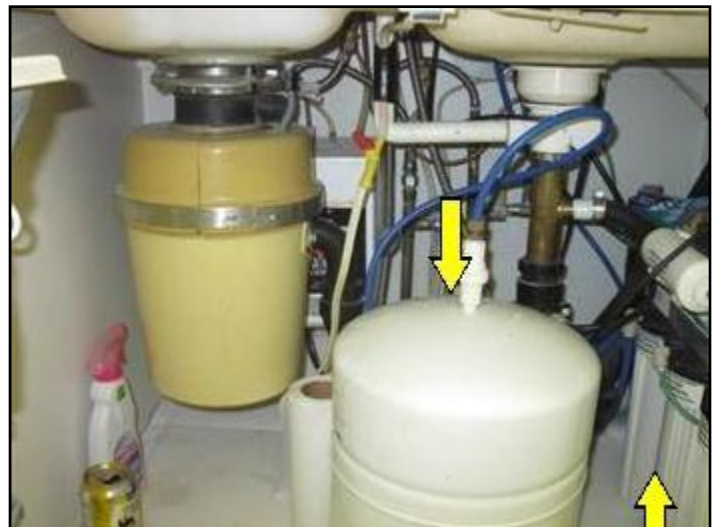
We noted several water treatment systems installed in the basement near the water main as well as under the kitchen sink.

Water treatment system under kitchen sink

These systems require regular maintenance and can become a source of water contamination if left unattended. Recommend having these serviced and if unnecessary, removed.

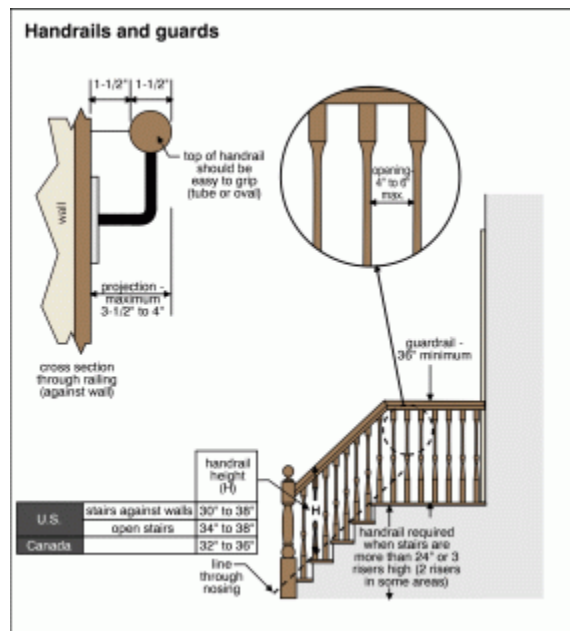
We noted a handrail is missing in the staircase leading to the basement. One should be added for safety reasons.

Handrail missing in staircase

Task: Provide

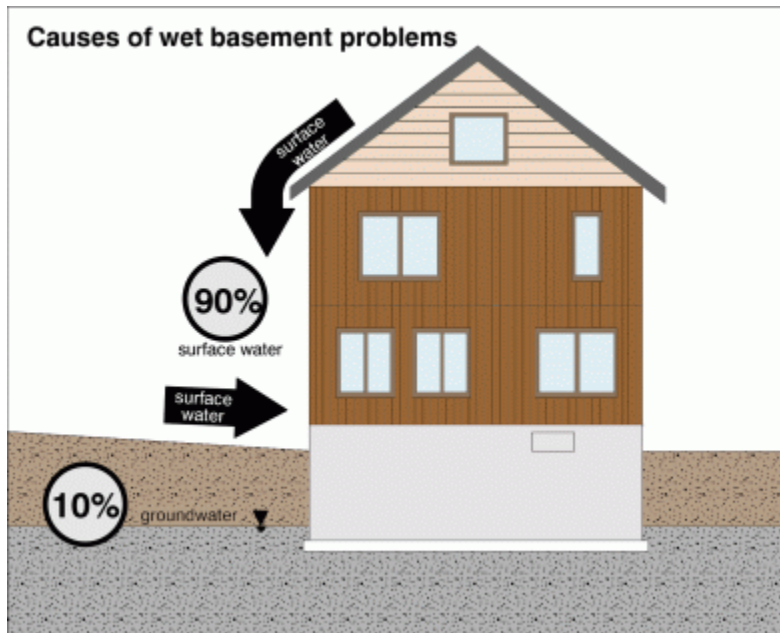
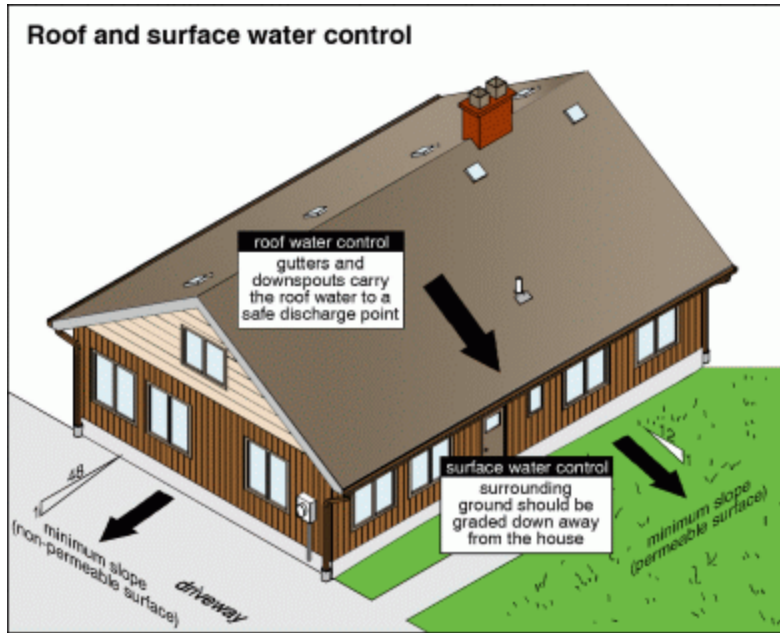
Condition: • [Poor gutters and downspouts](#)

Implication(s): Chance of water damage to contents, finishes and/or structure

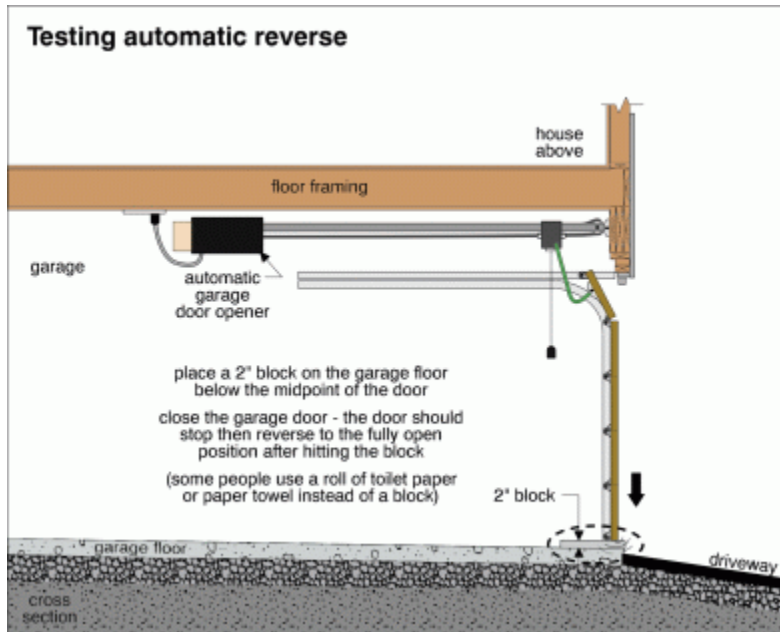
A test of the garage door openers revealed the devices are lacking proper safety devices and fail to auto reverse. Recommend replacing the units for safety reasons.

Infrared sensors missing on GDO's

Garage door openers fail test on auto-return

Task: Replace

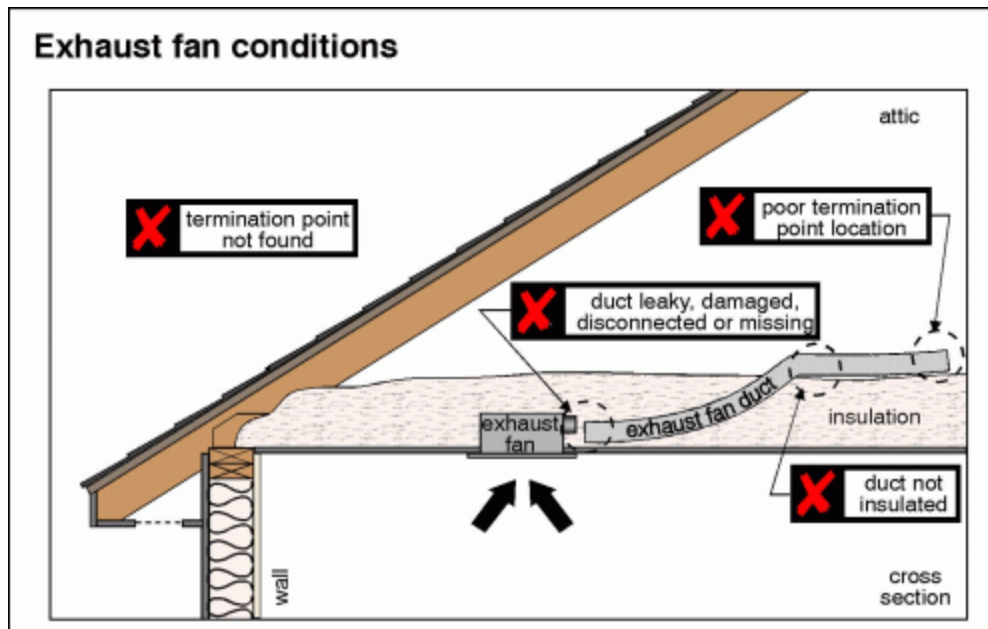
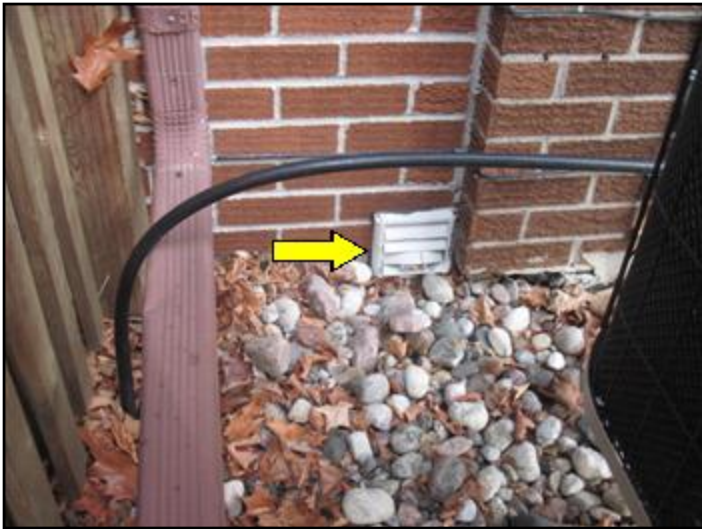
We noted vent hood installations that can affect the performance of venting equipment and that should be corrected.

Dryer vent hood too close to grade

Task: Correct
