# Your Inspection Report

107 - 5th Avenue  
Montreal, QC

RE: Report No. 1358, v.2  
107 - 5th Avenue  
Montreal, QC

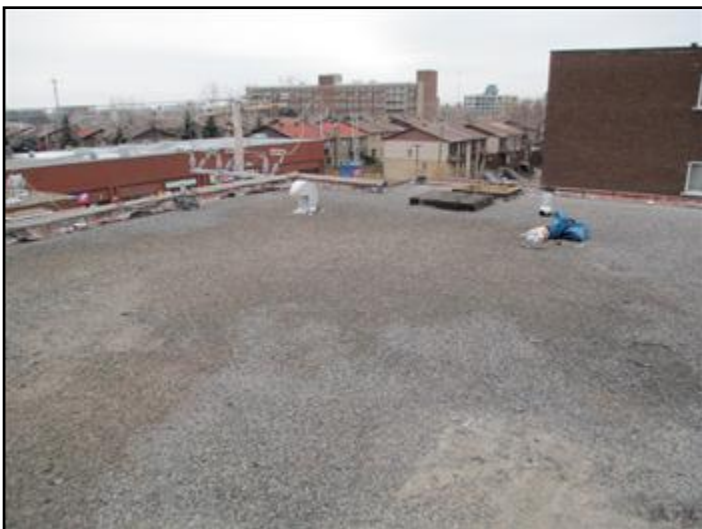
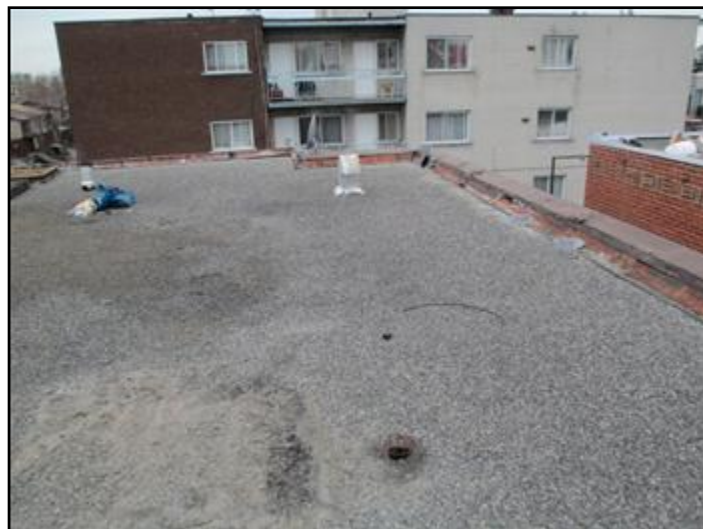
Partial view of roof towards the rear
